Access Compliance Report

Public Rights-of-Way

(Curb Ramps)

| Intersection ID: 3806 | Main Street: BRIARCREST_CT | Cross Street: CHESTNUT_KNOLL_LN | Location: E |

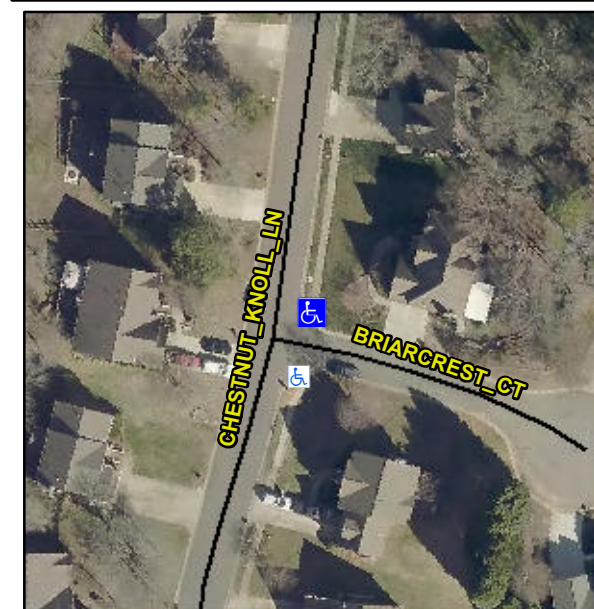
| ADA ID: 7D79FB900D8F | Ramp Type: Perp | Initial Pass/Fail: Fail | Overall Compliance: No |
| Severity Score: 21.25 | | | |

Not Found, R304.5.1, R304.5.3

| Compliance | Description | Data | Compliance | Description | Data |
|---|---|---|---|---|---|
| No | Ramp Width (in) | 46.0 | No | Ramp XSlope (%) | 6.9 |

Remove & Replace Entire Ramp.
