# Access Compliance Report

## Public Rights-of-Way

### (Curb Ramps)

| Intersection ID: 11389 | Main Street: E_18TH_ST | Cross Street: N_CALDWELL_ST | Location: N |

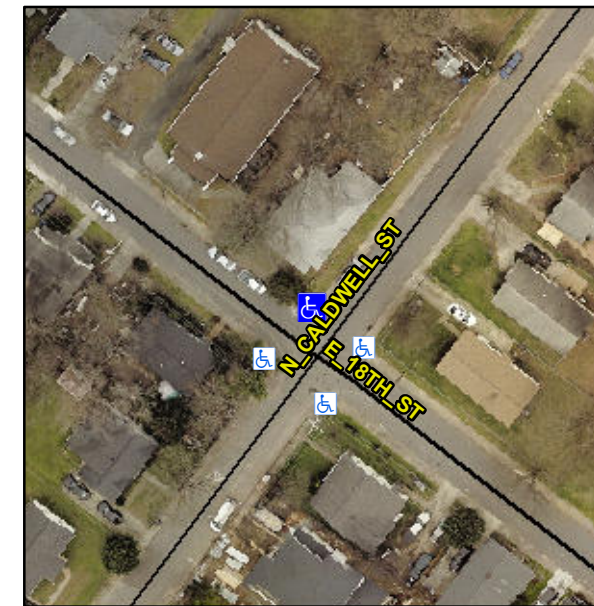
| ADA ID: 7F017DF5E5A7 | Ramp Type: PerpDiag | Initial Pass/Fail: Fail | Overall Compliance: No |

**Not Found, R304.5.1, R304.2.2, R304.5.3**

| Compliance | Description | Data | Compliance | Description | Data |
|---|---|---|---|---|---|
| N/A | Ramp Length (in) | 55.0 | No | Ramp Slope (%) | 14.5 |
| No | Ramp Width (in) | 46.0 | No | Ramp XSlope (%) | 6.4 |

**Remove & Replace Curb Ramp With Two New Directional Ramps or Equivalent.**
