Access Compliance Report

Public Rights-of-Way

(Curb Ramps)

Intersection ID: 9818	Main Street: EDGEWOOD_RD	Cross Street: LOCH_LEVEN_ST	Location: S
ADA ID: 7F926BD30B29	Ramp Type: Perp	Initial Pass/Fail: Fail	Overall Compliance: No
Severity Score: 36.25			
Codes/Mitigation Info/Possible Solution		Field Measurements/Component Compliance

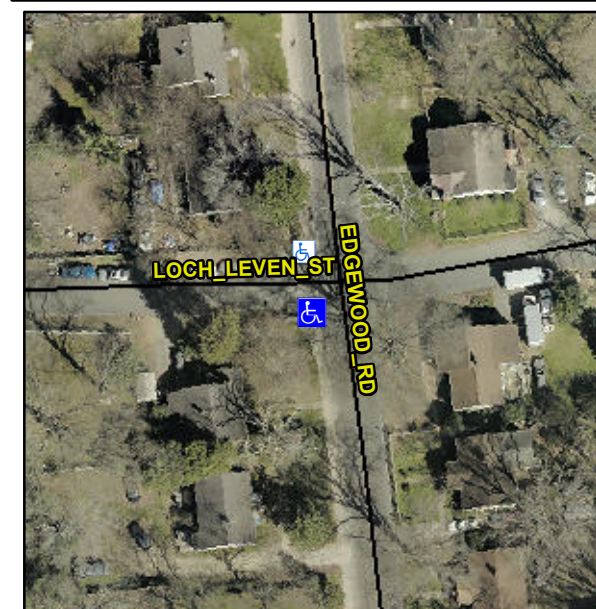
Not Found, R304.5.1, R304.5.3

Compliance	Description	Data	Compliance	Description	Data
N/A	Ramp Length (in)	87.0	Yes	Ramp Slope (%)	7.5
No	Ramp Width (in)	24.0	No	Ramp XSlope (%)	3.9
N/A	Flare Type LT	N/A	N/A	Flare Type RT	N/A
N/A	Flare Slope LT (%)	N/A	N/A	Flare Slope RT (%)	N/A
N/A	Flare Traversable LT?	N/A	N/A	Flare Traversable RT?	N/A
N/A	Landing Length (in)	N/A	N/A	DWS Provided?	N/A
N/A	Landing Width (in)	N/A	N/A	DWS Contrast?	N/A
N/A	Landing Slope (%)	N/A	N/A	DWS Length (in)	N/A
N/A	Landing X Slope (%)	N/A	N/A	DWS Full Width?	N/A
N/A	Landing Curb? (Y/N)	N/A	N/A	DWS Offset (in)	N/A
N/A	Shared Landing?	N/A			
N/A	Gutter Ponding?	N/A	N/A	Gutter Slope (%)	N/A
N/A	Gutter Lip Ht (in)	N/A	N/A	Gutter X Slope (%)	N/A
N/A	Painted X Walk1?	No	N/A	Painted X Walk2?	N/A
	X Walk 1 Direction	To N		X Walk 2 Direction	N/A
N/A	X Walk 1 Width (in)	N/A	N/A	X Walk 2 Width (in)	N/A
	X Walk 1 Slope (%)	1.4		X Walk 2 Slope (%)	N/A
	X Walk 1 X Slope (%)	3.5		X Walk 2 X Slope (%)	N/A

Remove & Replace Entire Ramp.
