Access Compliance Report

Public Rights-of-Way

(Curb Ramps)

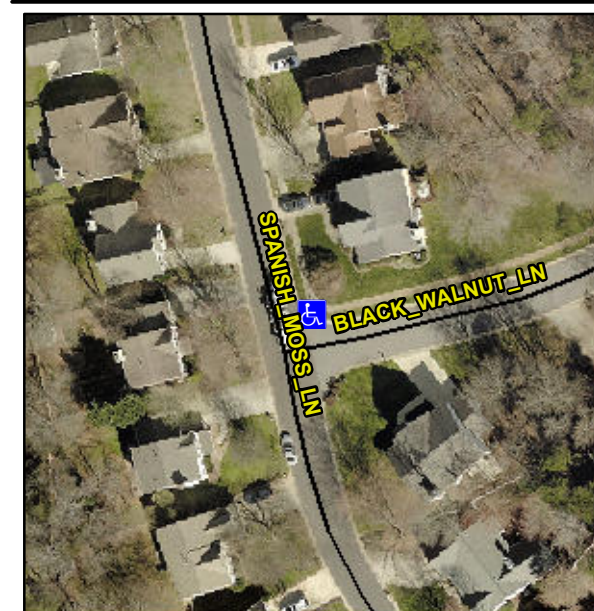
Intersection ID: 5861	Main Street: BLACK WALNUT LN	Cross Street: SPANISH MOSS LN	Location: NE
ADA ID: 7F958F6D4E06	Ramp Type: Perp	Initial Pass/Fail: Fail	Overall Compliance: No
Severity Score: 1.25			
Codes/Mitigation Info/Possible Solution		Field Measurements/Component Compliance

Not Found, R304.5.3

Compliance	Description	Data	Compliance	Description	Data
N/A	Ramp Length (in)	47.5	Yes	Ramp Slope (%)	7.0
Yes	Ramp Width (in)	55.0	No	Ramp XSlope (%)	2.6
N/A	Flare Type LT	N/A	N/A	Flare Type RT	N/A
N/A	Flare Slope LT (%)	N/A	N/A	Flare Slope RT (%)	N/A
N/A	Flare Traversable LT?	N/A	N/A	Flare Traversable RT?	N/A
N/A	Landing Length (in)	N/A	N/A	DWS Provided?	N/A
N/A	Landing Width (in)	N/A	N/A	DWS Contrast?	N/A
N/A	Landing Slope (%)	N/A	N/A	DWS Length (in)	N/A
N/A	Landing X Slope (%)	N/A	N/A	DWS Full Width?	N/A
N/A	Landing Curb? (Y/N)	N/A	N/A	DWS Offset (in)	N/A
N/A	Shared Landing?	N/A			
N/A	Gutter Ponding?	N/A	N/A	Gutter Slope (%)	N/A
N/A	Gutter Lip Ht (in)	0.75	N/A	Gutter X Slope (%)	N/A
N/A	Painted X Walk1?	No	N/A	Painted X Walk2?	N/A
	X Walk 1 Direction	To S		X Walk 2 Direction	N/A
N/A	X Walk 1 Width (in)	N/A	N/A	X Walk 2 Width (in)	N/A
	X Walk 1 Slope (%)	1.8		X Walk 2 Slope (%)	N/A
	X Walk 1 X Slope (%)	2.6		X Walk 2 X Slope (%)	N/A

Remove & Replace Entire Ramp.

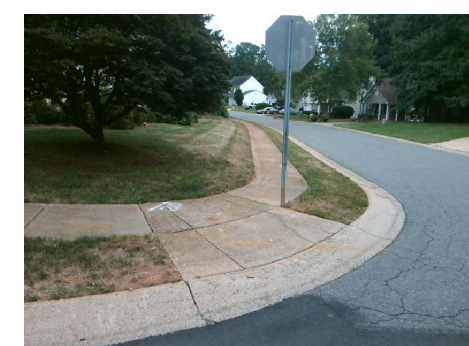
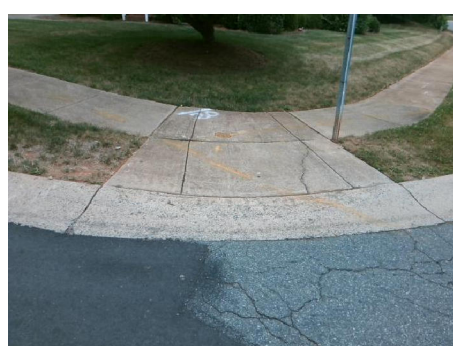
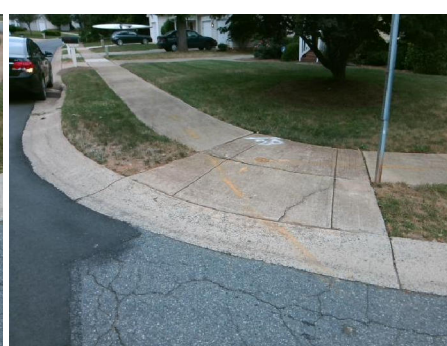
N/A	Ramp inside XWalk1?	N/A	N/A	Ramp inside XWalk2?	N/A
	Road Slope (%)	N/A	N/A	Clear Space?	N/A
	Road X Slope (%)	N/A	N/A	Clear Space to XWalk (in)	N/A
N/A	Any Obstructions?	N/A	N/A	Storm Grate/Utility Hazard?	N/A
	Obstruction Type			Storm Grate/Utility Type	
		N/A			N/A
		Yes		Surface Condition? (G/P)	Good
