# Access Compliance Report

## Public Rights-of-Way

### (Curb Ramps)

| Intersection ID: 15397 | Main Street: N_WENDOVER_RD | Cross Street: N_WENDOVER_RD_RA | Location: | N |

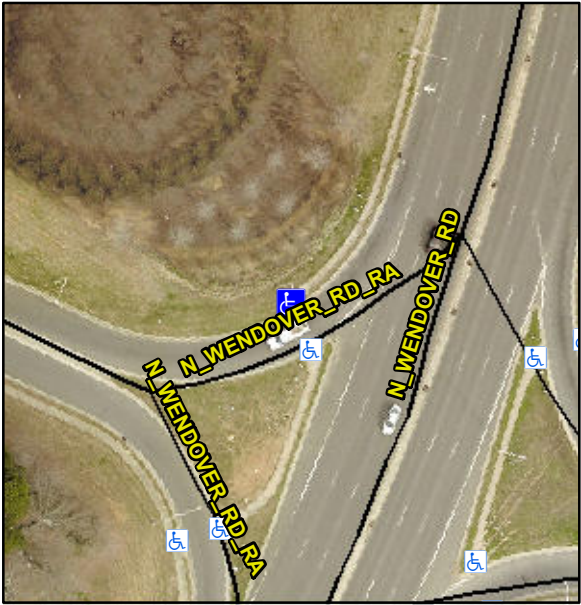
| ADA ID: 802A538706B6 | Ramp Type: Perp | Initial Pass/Fail: Pass | Overall Compliance: No | Severity Score: 12.5 |

| Codes/Mitigation Info/Possible Solution | | | Field Measurements/Component Compliance | | |
|---|---|--|---|---|---|
| <p>Surveyor Notes:</p> <p>N/A</p> <p>PROW/ADA:</p> <p>Not Found, R304.2.1, R304.2.2-Perp, R304.3.2-Para, R304.5.3, R305.1.4, R305.2</p> | | | N/A | Flare Type RT | N/A |
| | | | No | DWS Full Width? | No |
| | | | No | DWS Offset (in) | 2.5 |
| | | | No | Gutter X Slope (%) | 2.8 |

| Codes/Mitigation Info/Possible Solution | | | Field Measurements/Component Compliance | | |
|---|---|--|---|---|---|
| | Remove & Replace Entire Ramp. | | N/A | Ramp Length (in) | 81.0 |
| | Remove & Replace Gutter. | | Yes | Ramp Width (in) | 49.5 |
| <p>Total Cost:</p> <p>\$ 2600.00</p> | | | N/A | Clear Space to XWalk (in) | N/A |
