Access Compliance Report Public Rights-of-Way (Curb Ramps)

Intersection ID: 10026800 Main Street: FOREST POINT BV Cross Street: N/A Location: SW **Overall Compliance: No** ADA ID: 805101962FF1 Ramp Type: Directional1 Initial Pass/Fail: Pass **Severity Score:** 15

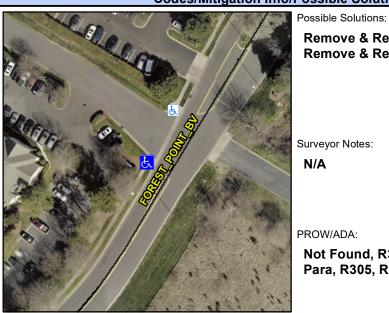
Field Measurements/Component Compliance							
Compliance Description		Data	Comp	liance	Description	Data	
N/A	Ramp Length (in)	46.0	Yes	Grade	Break?	Yes	
Yes	Ramp Width (in)	50.0	Yes	Grade	Break Slope (%)	4.0	
Yes	Ramp Slope (%)	6.1	Yes	Grade	Break XSlope (%)	2.4	
Yes	Ramp XSlope (%)	1.7					
N/A	Flare Type LT	N/A	N/A	Flare ⁻	Гуре RT	N/A	
N/A	Flare Slope LT (%)	N/A	N/A	Flare	Slope RT (%)	N/A	
N/A	Flare Traversable LT?	N/A	N/A	Flare ⁻	Traversable RT?	N/A	
Yes	Landing Length (in)	48.0	No	DWS	Provided?	No	
Yes	Landing Width (in)	50.0	N/A	DWS	Contrast?	No	
No	Landing Slope (%)	4.1	N/A	DWS	Length (in)	N/A	
Yes	Landing X Slope (%)	2.8	N/A	DWS	Full Width?	No	
N/A	Landing Curb? (Y/N)	N/A	N/A	DWS	Offset LT (in)	N/A	
N/A	Shared Landing?	No	N/A	DWS	Offset RT (in)	N/A	
Yes	Gutter Ponding?	No	No	Gutter	Slope (%)	8.7	
Yes	Gutter Lip Ht (in)	0.0	Yes	Gutter	X Slope (%)	1.7	
N/A	Painted X Walk1?	No		Road	Slope (%)	2.3	
	X Walk 1 Direction	To N		Road 2	X Slope (%)	7.1

X Walk 1 Width (in)	N/A		Clear	Space?	Yes	
	X Walk 1 Slope (%)	2.3	N/A	Clear	Space to XWalk (in)	N/A	
	X Walk 1 X Slope (%)	7.1	Yes	Storm	Grate/Utility Hazard?	No	
N/A	Ramp inside XWalk1?	N/A		Storm	Grate/Utility Type		
Yes	Any Obstructions?	No				N/A	
	Obstruction Type		Yes	Surfac	e Condition? (G/P)	Good	
		N/A	No	Curb S	Slope (%)	12.3

Pro-	1 Ossible Solutions.
の大きながら	Remove & Replace Entire Ramp. Remove & Replace Gutter.
1 March 100	Surveyor Notes: N/A
	PROW/ADA: Not Found, R304.2.2-Perp, R304.3.2- Para, R305, R304.5.4
7

Total Cost:	\$	2350.00
