# Access Compliance Report

## Public Rights-of-Way

### (Curb Ramps)

Intersection ID: 50608	Main Street: DENBUR_DR	Cross Street: DOWNY_BIRCH_RD	Location: NE
ADA ID: 805FC987027D	Ramp Type: Perp	Initial Pass/Fail: Pass	Overall Compliance: No
Severity Score: 10.25			
Codes/Mitigation Info/Possible Solution		Field Measurements/Component Compliance

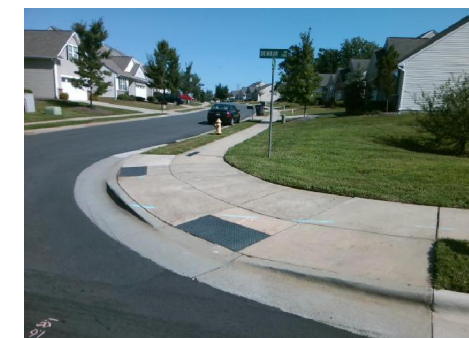
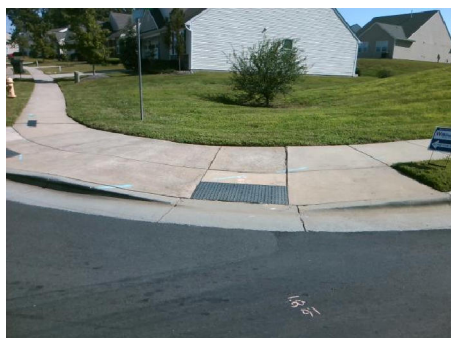
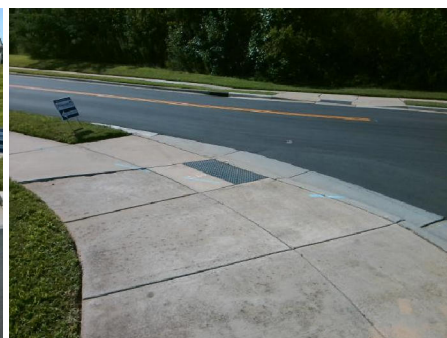
**Not Found, R304.5.3, R304.2.1, R304.2.2-Perp, R304.3.2-Para**

Compliance	Description	Data	Compliance	Description	Data
N/A	Ramp Length (in)	106.0	Yes	Ramp Slope (%)	7.3
Yes	Ramp Width (in)	48.0	No	Ramp XSlope (%)	2.4
N/A	Flare Type LT	Sloped	N/A	Flare Type RT	N/A
N/A	Flare Slope LT (%)	3.7	N/A	Flare Slope RT (%)	9.6
N/A	Flare Traversable LT?	No	N/A	Flare Traversable RT?	No
No	Landing Length (in)	N/A	Yes	DWS Provided?	Yes
No	Landing Width (in)	N/A	Yes	DWS Contrast?	Yes
No	Landing Slope (%)	N/A	Yes	DWS Length (in)	24.5
No	Landing X Slope (%)	N/A	Yes	DWS Full Width?	Yes
N/A	Landing Curb? (Y/N)	No	Yes	DWS Offset (in)	1.0
N/A	Shared Landing?	No			
Yes	Gutter Ponding?	No	Yes	Gutter Slope (%)	4.4
Yes	Gutter Lip Ht (in)	0.0	Yes	Gutter X Slope (%)	1.9
N/A	Painted X Walk1?	No	N/A	Painted X Walk2?	N/A
	X Walk 1 Direction	To S		X Walk 2 Direction	N/A
N/A	X Walk 1 Width (in)	N/A	N/A	X Walk 2 Width (in)	N/A
	X Walk 1 Slope (%)	1.8		X Walk 2 Slope (%)	N/A
	X Walk 1 X Slope (%)	1.6		X Walk 2 X Slope (%)	N/A

N/A	Ramp inside XWalk1?	N/A	N/A	Ramp inside XWalk2?	N/A
	Road Slope (%)	N/A	N/A	Clear Space?	Yes
	Road X Slope (%)	N/A	N/A	Clear Space to XWalk (in)	N/A
Yes	Any Obstructions?	No	Yes	Storm Grate/Utility Hazard?	No
	Obstruction Type			Storm Grate/Utility Type	
			N/A		N/A
			Yes	Surface Condition? (G/P)	Good

**Remove & Replace Entire Ramp.**
