# Access Compliance Report

## Public Rights-of-Way

### (Curb Ramps)

| Intersection ID: 6341 | Main Street: DAFFODIL_DR | Cross Street: MILHAVEN_LN | Location: | W |

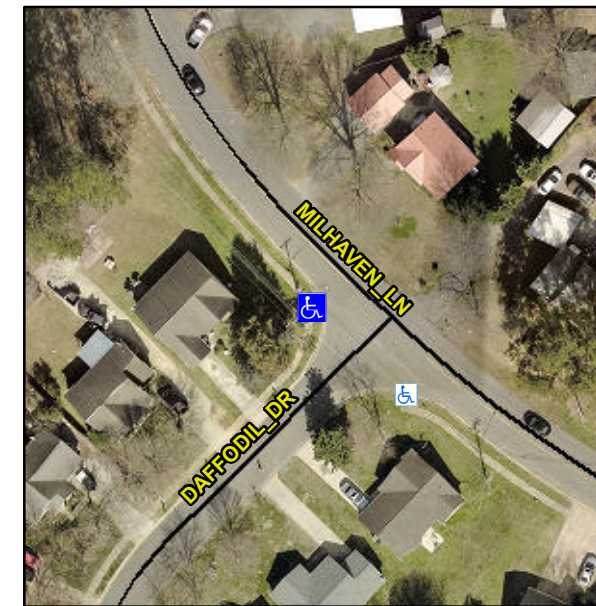
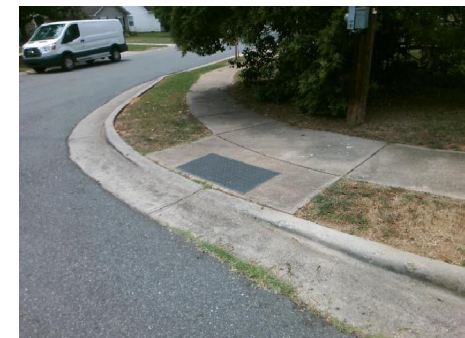
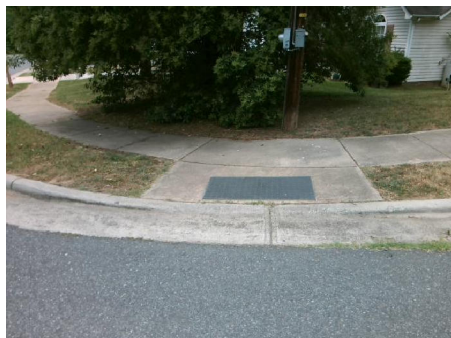
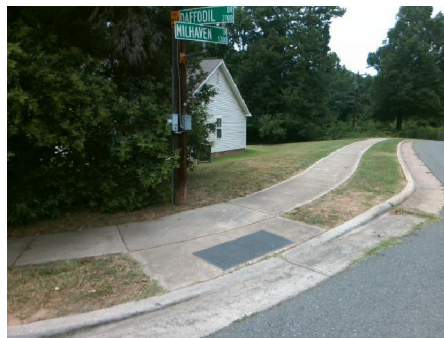
| ADA ID: 80F30AE88EFB | Ramp Type: BlendTrans1 | Initial Pass/Fail: Fail | Overall Compliance: No | Severity Score: 1.25 |

**CURB GAP 1.0**

**Not Found, R304.5.3**

| Compliance | Description | Data | Compliance | Description | Data |
|---|---|---|---|---|---|
| Yes | Ramp Width (in) | 48.0 | No | BlendTrans XSlope (%) | 4.4 |
| | | | No | Curb Slope (%) | 20.8 |

**Remove & Replace Curb Ramp With Two New Directional Ramps or Equivalent.**
