Access Compliance Report

Public Rights-of-Way

(Curb Ramps)

| Intersection ID: 6882 | Main Street: STATESVILLE_RD | Cross Street: CINDY_LN | Location: NW |

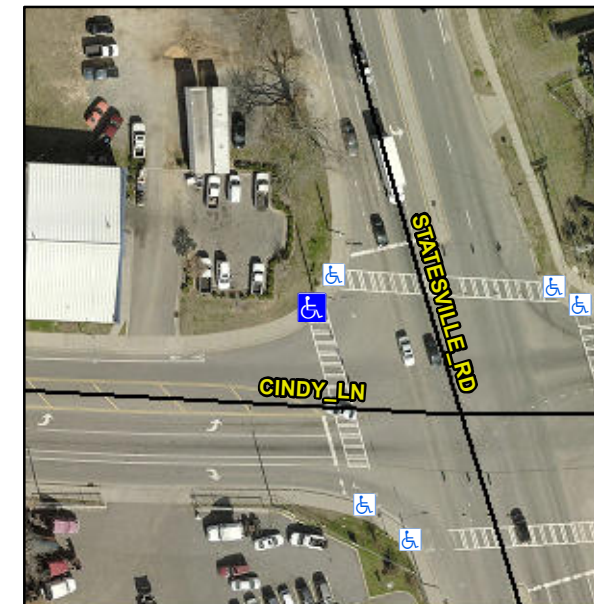
| ADA ID: 81FFDF5FBF18 | Ramp Type: Para | Initial Pass/Fail: Fail | Overall Compliance: No |
| Severity Score: 12.5 | | | |

R304.3.2

| Compliance | Description | Data | Compliance | Description | Data |
|---|---|---|---|---|---|
| Yes | Ramp Slope LT (%) | 6.2 | No | Ramp Slope RT (%) | 8.9 |

Remove & Replace Entire Ramp.
