Access Compliance Report Public Rights-of-Way (Curb Ramps)

Intersection ID: 54402Main Street:SPRINGMAN_LNCross Street:LOMA_LINDA_LNLocation:SEADA ID: 82229F95C356Ramp Type:PerpInitial Pass/Fail:FailOverall Compliance:NoSeverity Score:25

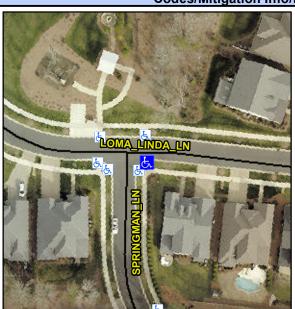
Field Measurements/Component Compnance						
Compl	iance Description	Data	Comp	liance Description	Data	
N/A	Ramp Length (in)	96.0	Yes	Ramp Slope (%)	6.2	
Yes	Ramp Width (in)	48.0	No	Ramp XSlope (%)	8.3	
N/A	Flare Type LT	N/A	N/A	Flare Type RT	N/A	
N/A	Flare Slope LT (%)	N/A	N/A	Flare Slope RT (%)	N/A	
N/A	Flare Traversable LT?	N/A	N/A	Flare Traversable RT?	N/A	
N/A	Landing Length (in)	N/A	N/A	DWS Provided?	N/A	
N/A	Landing Width (in)	N/A	N/A	DWS Contrast?	N/A	
N/A	Landing Slope (%)	N/A	N/A	DWS Length (in)	N/A	
N/A	Landing X Slope (%)	N/A	N/A	DWS Full Width?	N/A	
N/A	Landing Curb? (Y/N)	N/A	N/A	DWS Offset (in)	N/A	
N/A	Shared Landing?	N/A				
N/A	Gutter Ponding?	N/A	N/A	Gutter Slope (%)	N/A	
N/A	Gutter Lip Ht (in)	N/A	N/A	Gutter X Slope (%)	N/A	
N/A	Painted X Walk1?	No	N/A	Painted X Walk2?	N/A	
	X Walk 1 Direction	To N		X Walk 2 Direction	N/A	
N/A	X Walk 1 Width (in)	N/A	N/A	X Walk 2 Width (in)	N/A	
	X Walk 1 Slope (%)	3.9		X Walk 2 Slope (%)	N/A

X Walk 1 X Slope (%)	6.2		X Walk 2 X Slope (%)	N/A	
N/A	Ramp inside XWalk1?	N/A	N/A	Ramp inside XWalk2?	N/A	
	Road Slope (%)	N/A	N/A	Clear Space?	N/A	
	Road X Slope (%)	N/A	N/A	Clear Space to XWalk (in)	N/A	
N/A	Any Obstructions?	N/A	N/A	Storm Grate/Utility Hazard?	N/A	
	Obstruction Type			Storm Grate/Utility Type		
		N/A			N/A	
			Yes	Surface Condition? (G/P)	Good

TO CONTROL CON	
Possible Solutions:	
Remove & Replace Entire Ramp.	ı
	`
	ı
	I
	I
	I
Surveyor Notes:	ı
N/A	ı
	!
DDOW/ADA	
PROW/ADA:	
Not Found, R304.5.3	
	'
	ı
	'
