# Access Compliance Report

## Public Rights-of-Way

### (Curb Ramps)

Intersection ID: 46816	Main Street: CYPRESS_VIEW_DR	Cross Street: ARBOR_VISTA_DR	Location: NE
ADA ID: 826E560CB070	Ramp Type: PerpDiag	Initial Pass/Fail: Fail	Overall Compliance: No
Severity Score: 46.25			
Codes/Mitigation Info/Possible Solution		Field Measurements/Component Compliance

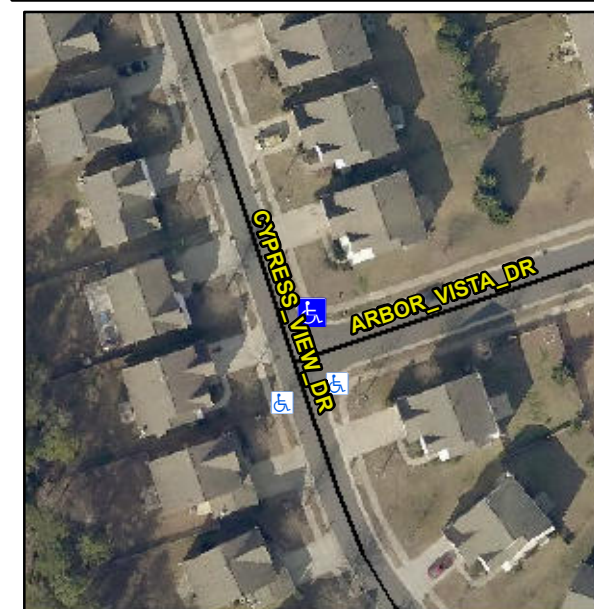
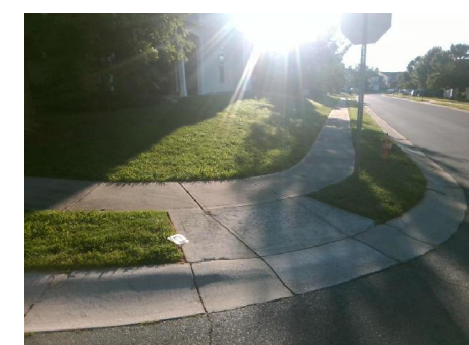
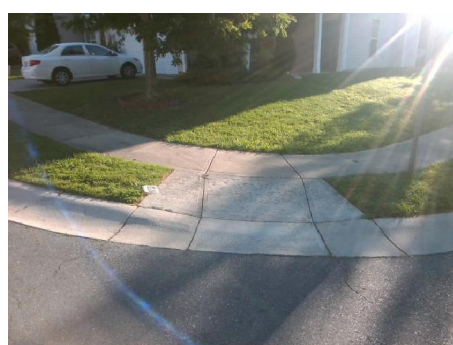
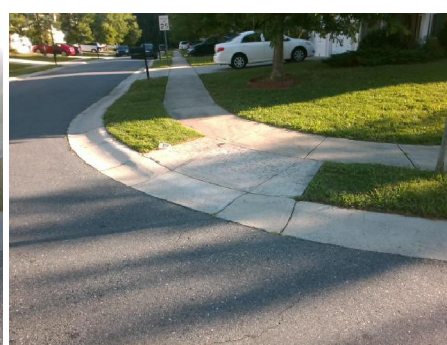
**R304.5.1, R304.2.2, R304.5.3**

Compliance	Description	Data	Compliance	Description	Data
N/A	Ramp Length (in)	46.5	No	Ramp Slope (%)	13.3
No	Ramp Width (in)	45.5	No	Ramp XSlope (%)	6.1
N/A	Flare Type LT	N/A	N/A	Flare Type RT	N/A
N/A	Flare Slope LT (%)	N/A	N/A	Flare Slope RT (%)	N/A
N/A	Flare Traversable LT?	N/A	N/A	Flare Traversable RT?	N/A
N/A	Landing Length (in)	N/A	N/A	DWS Provided?	N/A
N/A	Landing Width (in)	N/A	N/A	DWS Contrast?	N/A
N/A	Landing Slope (%)	N/A	N/A	DWS Length (in)	N/A
N/A	Landing X Slope (%)	N/A	N/A	DWS Full Width?	N/A
N/A	Landing Curb? (Y/N)	N/A	N/A	DWS Offset (in)	N/A
N/A	Shared Landing?	N/A			
N/A	Gutter Ponding?	N/A	N/A	Gutter Slope (%)	N/A
N/A	Gutter Lip Ht (in)	N/A	N/A	Gutter X Slope (%)	N/A
N/A	Painted X Walk1?	No	N/A	Painted X Walk2?	No
	X Walk 1 Direction	To W		X Walk 2 Direction	To S
N/A	X Walk 1 Width (in)	N/A	N/A	X Walk 2 Width (in)	N/A
	X Walk 1 Slope (%)	5.9		X Walk 2 Slope (%)	1.5
	X Walk 1 X Slope (%)	3.5		X Walk 2 X Slope (%)	5.2

N/A	Ramp inside XWalk1?	N/A	N/A	Ramp inside XWalk2?	N/A
	Road Slope (%)	6.3	N/A	Clear Space?	N/A
	Road X Slope (%)	2.5	N/A	Clear Space to XWalk (in)	N/A
N/A	Any Obstructions?	N/A	N/A	Storm Grate/Utility Hazard?	N/A
	Obstruction Type			Storm Grate/Utility Type	
		N/A			N/A
			Yes	Surface Condition? (G/P)	Good

**Remove & Replace Curb Ramp With Two New Directional Ramps or Equivalent.**
