# Access Compliance Report

## Public Rights-of-Way

Intersection ID: 50321	Main Street: BELMAR_PLACE_RD	Cross Street: CINDY_LN	Location: SW
ADA ID: 82809CB4D27B	Ramp Type: Directional1	Initial Pass/Fail: Fail	Overall Compliance: No
		Severity Score: 12.5

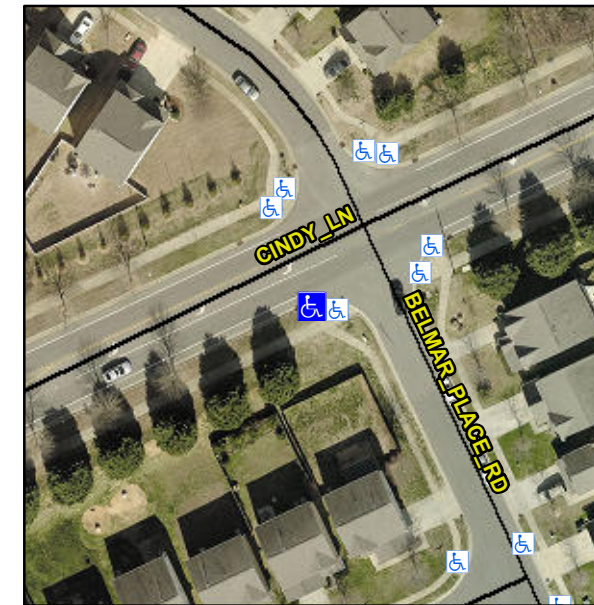
Compliance	Description	Data	Compliance	Description	Data
N/A	Ramp Length (in)	76.0	N/A	Grade Break?	N/A
Yes	Ramp Width (in)	67.5	N/A	Grade Break Slope (%)	0.0
Yes	Ramp Slope (%)	7.9	N/A	Grade Break XSlope (%)	0.0
No	Ramp XSlope (%)	5.8			
N/A	Flare Type LT	N/A	N/A	Flare Type RT	N/A
N/A	Flare Slope LT (%)	N/A	N/A	Flare Slope RT (%)	0.0
N/A	Flare Traversable LT?	N/A	N/A	Flare Traversable RT?	N/A
N/A	Landing Length (in)	0.0	N/A	DWS Provided?	N/A
N/A	Landing Width (in)	0.0	N/A	DWS Contrast?	N/A
N/A	Landing Slope (%)	0.0	N/A	DWS Length (in)	N/A
N/A	Landing X Slope (%)	0.0	N/A	DWS Full Width?	N/A
N/A	Landing Curb? (Y/N)	N/A	N/A	DWS Offset LT (in)	N/A
N/A	Shared Landing?	N/A	N/A	DWS Offset RT (in)	N/A
N/A	Gutter Ponding?	0.0	N/A	Gutter Slope (%)	N/A
N/A	Gutter Lip Ht (in)	0.0	N/A	Gutter X Slope (%)	N/A
N/A	Painted X Walk1?	No		Road Slope (%)	1.1
	X Walk 1 Direction	To N		Road X Slope (%)	4.8
	X Walk 1 Width (in)	N/A		Clear Space?	N/A

**Remove & Replace Entire Ramp.**

**R304.5.3**

\$ 1600.00
