Access Compliance Report

Public Rights-of-Way

(Curb Ramps)

Intersection ID: 11229	Main Street: DRUMMOND_AV	Cross Street: LYDIA_AV	Location: SW
ADA ID: 82858CEE3E71	Ramp Type: Perp	Initial Pass/Fail: Fail	Overall Compliance: No
Severity Score: 25			
Codes/Mitigation Info/Possible Solution		Field Measurements/Component Compliance

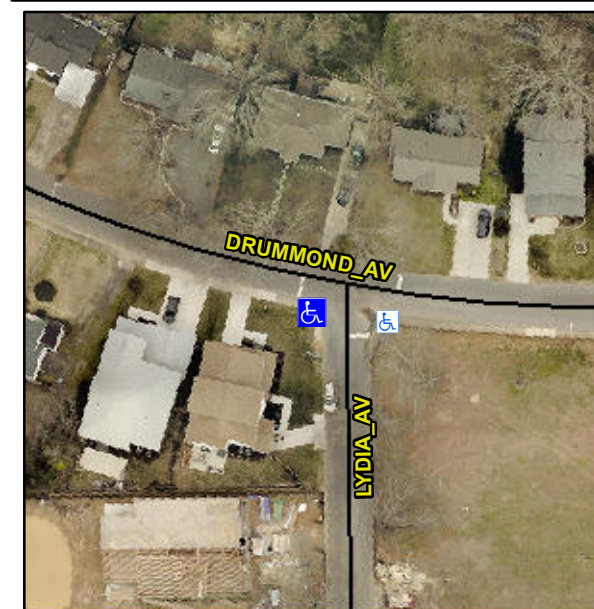
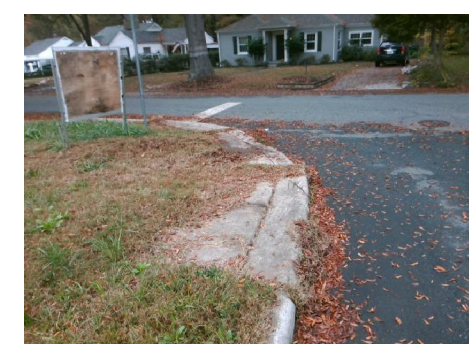
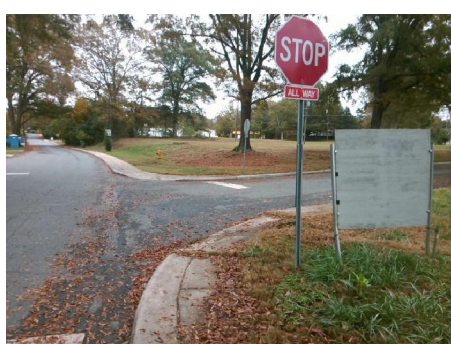
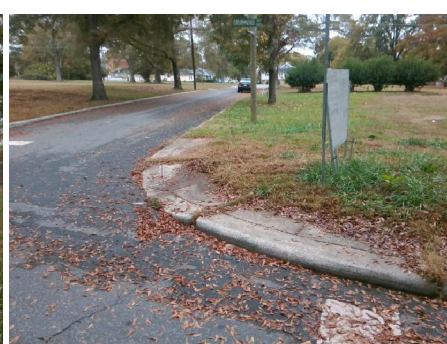
Not Found, R304.2.2

Compliance	Description	Data	Compliance	Description	Data
N/A	Ramp Length (in)	37.0	No	Ramp Slope (%)	14.6
Yes	Ramp Width (in)	48.0	Yes	Ramp XSlope (%)	0.5
N/A	Flare Type LT	N/A	N/A	Flare Type RT	N/A
N/A	Flare Slope LT (%)	N/A	N/A	Flare Slope RT (%)	N/A
N/A	Flare Traversable LT?	N/A	N/A	Flare Traversable RT?	N/A
N/A	Landing Length (in)	N/A	N/A	DWS Provided?	N/A
N/A	Landing Width (in)	N/A	N/A	DWS Contrast?	N/A
N/A	Landing Slope (%)	N/A	N/A	DWS Length (in)	N/A
N/A	Landing X Slope (%)	N/A	N/A	DWS Full Width?	N/A
N/A	Landing Curb? (Y/N)	N/A	N/A	DWS Offset (in)	N/A
N/A	Shared Landing?	N/A			
N/A	Gutter Ponding?	N/A	N/A	Gutter Slope (%)	N/A
N/A	Gutter Lip Ht (in)	N/A	N/A	Gutter X Slope (%)	N/A
N/A	Painted X Walk1?	No	N/A	Painted X Walk2?	N/A
	X Walk 1 Direction	To E		X Walk 2 Direction	N/A
N/A	X Walk 1 Width (in)	N/A	N/A	X Walk 2 Width (in)	N/A
	X Walk 1 Slope (%)	3.3		X Walk 2 Slope (%)	N/A
	X Walk 1 X Slope (%)	1.6		X Walk 2 X Slope (%)	N/A

Remove & Replace Entire Ramp.
