Access Compliance Report Public Rights-of-Way (Curb Ramps)

Intersection ID: 52467 Main Street: ACQUINAS_PL Cross Street: ST_JOHN_LN Location: S

ADA ID: 82ABB01538F2 Ramp Type: BlendTrans1 Initial Pass/Fail: Fail Overall Compliance: No Severity Score: 10

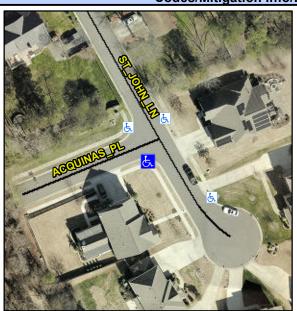
RAMP LIP 0.5

Not Found, R304.5.1, R304.5.3

Compli	iance Description	Data		Data	
	Compliance Description N/A Ramp Length (in)		47.0	Yes BlendTrans Slope (%)		4.7
	No No	Ramp Width (in)	47.5	No	BlendTrans XSlope (%)	4.7 2.7
	N/A	. ,	47.5 N/A	N/A	. ,	2.7 N/A
		Flare Type LT			Flare Clare RT	
	N/A	Flare Slope LT (%)	N/A	N/A	Flare Slope RT (%)	N/A
	N/A	Flare Traversable LT?	N/A	N/A	Flare Traversable RT?	N/A
	N/A	Landing Length (in)	N/A	N/A	DWS Provided?	N/A
	N/A	Landing Width (in)	N/A	N/A	DWS Contrast?	N/A
	N/A	Landing Slope (%)	N/A	N/A	DWS Length (in)	N/A
	N/A	Landing X Slope (%)	N/A	N/A	DWS Full Width?	N/A
	N/A	Landing Curb? (Y/N)	N/A	N/A	DWS Offset (in)	N/A
	N/A	Shared Landing?	N/A			
	N/A	Gutter Ponding?	N/A	N/A	Gutter Slope (%)	N/A
	N/A	Gutter Lip Ht (in)	N/A	N/A	Gutter X Slope (%)	N/A
	N/A	Painted X Walk1?	No	N/A	Painted X Walk2?	No
		X Walk 1 Direction	To E		X Walk 2 Direction	To NW
		X Walk 1 Width (in)	N/A		X Walk 2 Width (in)	N/A
		X Walk 1 Slope (%)	4.3		X Walk 2 Slope (%)	5.8

X Walk 1 X Slope (%)	4.4		X Walk 2 X Slope (%)	5.7
	N/A	Ramp inside XWalk1?	N/A	N/A	Ramp inside XWalk2?	N/A
		Road Slope (%)	0.1		Clear Space?	N/A
		Road X Slope (%)	5.8	N/A	Clear Space to XWalk (in)	N/A
	N/A	Any Obstructions?	N/A	N/A	Storm Grate/Utility Hazard?	N/A
		Obstruction Type			Storm Grate/Utility Type	
			N/A			N/A
				Yes	Surface Condition? (G/P)	Good
15	\$ 1 kg			No	Curb Slope (%)	8.5

Remove & Replace Curb Ramp With Two New Directional Ramps or Equivalent.
