# Access Compliance Report

## Public Rights-of-Way

### (Curb Ramps)

Intersection ID: 48304	Main Street: FAZENDA_DR	Cross Street: GANSO_LN	Location:	E
ADA ID: 83637381543D	Ramp Type: PerpDiag	Initial Pass/Fail: Fail	Overall Compliance: No	Severity Score: 25

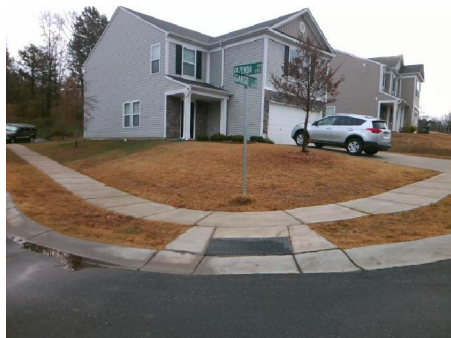
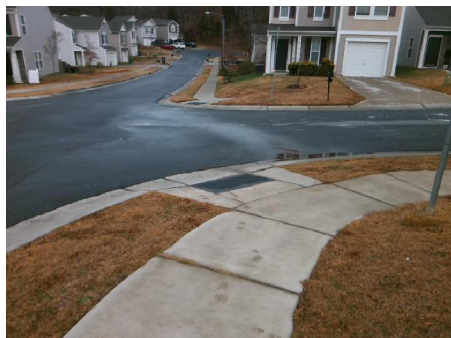
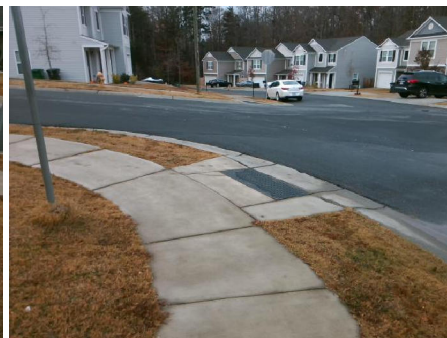
**Not Found, R304.2.2, R304.5.3**

Compliance	Description	Data	Compliance	Description	Data
N/A	Ramp Length (in)	49.0	No	Ramp Slope (%)	10.5
Yes	Ramp Width (in)	48.0	No	Ramp XSlope (%)	6.8
N/A	Flare Type LT	N/A	N/A	Flare Type RT	N/A
N/A	Flare Slope LT (%)	N/A	N/A	Flare Slope RT (%)	N/A
N/A	Flare Traversable LT?	N/A	N/A	Flare Traversable RT?	N/A
N/A	Landing Length (in)	N/A	N/A	DWS Provided?	N/A
N/A	Landing Width (in)	N/A	N/A	DWS Contrast?	N/A
N/A	Landing Slope (%)	N/A	N/A	DWS Length (in)	N/A
N/A	Landing X Slope (%)	N/A	N/A	DWS Full Width?	N/A
N/A	Landing Curb? (Y/N)	N/A	N/A	DWS Offset (in)	N/A
N/A	Shared Landing?	N/A			
N/A	Gutter Ponding?	N/A	N/A	Gutter Slope (%)	N/A
N/A	Gutter Lip Ht (in)	N/A	N/A	Gutter X Slope (%)	N/A
N/A	Painted X Walk1?	No	N/A	Painted X Walk2?	No
	X Walk 1 Direction	To NW		X Walk 2 Direction	To SW
N/A	X Walk 1 Width (in)	N/A	N/A	X Walk 2 Width (in)	N/A
	X Walk 1 Slope (%)	1.4		X Walk 2 Slope (%)	4.2
	X Walk 1 X Slope (%)	3.5		X Walk 2 X Slope (%)	6.3

N/A	Ramp inside XWalk1?	N/A	N/A	Ramp inside XWalk2?	N/A
	Road Slope (%)	4.5	N/A	Clear Space?	N/A
	Road X Slope (%)	1.9	N/A	Clear Space to XWalk (in)	N/A
N/A	Any Obstructions?	N/A	N/A	Storm Grate/Utility Hazard?	N/A
	Obstruction Type			Storm Grate/Utility Type	
		N/A			N/A
			Yes	Surface Condition? (G/P)	Good

**Remove & Replace Curb Ramp With Two New Directional Ramps or Equivalent.**
