Access Compliance Report

Public Rights-of-Way (Curb Ramps)

| Intersection ID: 10025574 | Main Street: E_W_T_HARRIS_BV | Cross Street: N/A | Location: NW |
| ADA ID: 83C077ED8E9A | Ramp Type: Combination1 | Initial Pass/Fail: Fail | Overall Compliance: No |

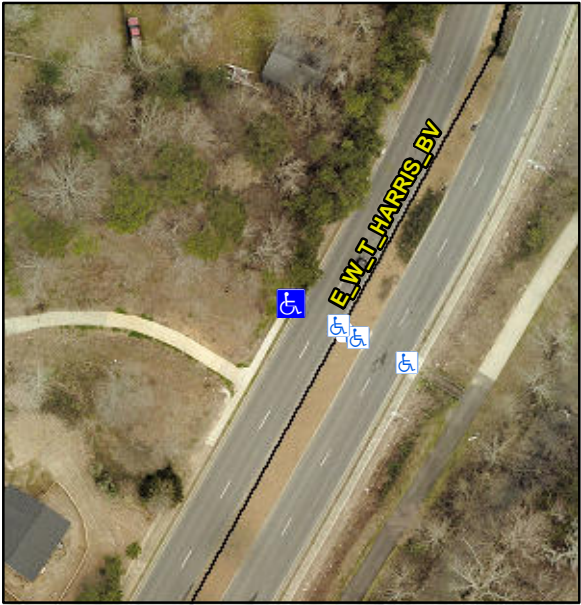
| | | | Severity Score: 8.75 |

| Codes/Mitigation Info/Possible Solution | | | Field Measurements/Component Compliance | | |
|---|---|--|---|---|---|
| | Remove & Replace Sidewalk. | | No | Ramp Width LT (in) | 47.0 |
| <p>PROW/ADA:</p> <p>Not Found, R304.5.1</p> | | | N/A | Landing Length (in) | N/A |

| Codes/Mitigation Info/Possible Solution | | | Field Measurements/Component Compliance | | |
|---|---|--|---|---|---|
| | Possible Solutions: | | Compliance | Description | Data |
| | Remove & Replace Entire Ramp. | | N/A | Ramp Length LT (in) | 75.0 |
| <p>Total Cost:</p> <p>\$ 2200.00</p> | | | N/A | X Walk 1 Width (in) | N/A |
