# Access Compliance Report

## Public Rights-of-Way

### (Curb Ramps)

| Intersection ID: 12983 | Main Street: E_TRADE_ST | Cross Street: N_MYERS_ST | Location: W |

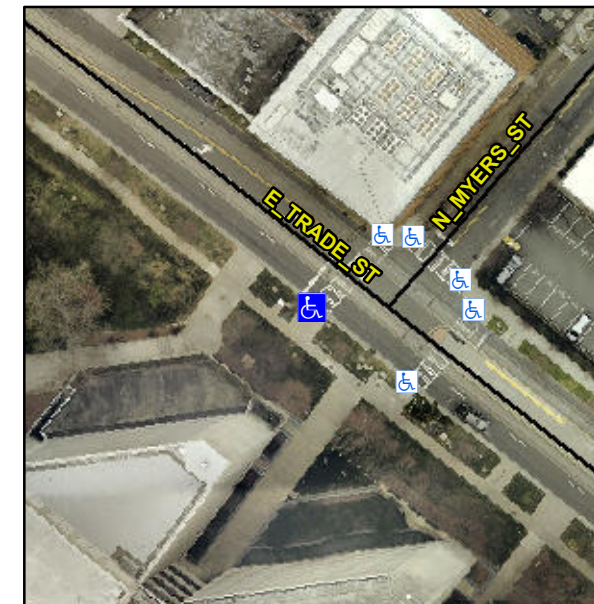
| ADA ID: 83C92F2F7BC3 | Ramp Type: Perp | Initial Pass/Fail: Fail | Overall Compliance: No |
| | | Severity Score: 12.5 | |

**Not Found, R304.5.3**

| Compliance | Description | Data | Compliance | Description | Data |
|---|---|---|---|---|---|
| Yes | Ramp Width (in) | 48.0 | No | Ramp XSlope (%) | 5.2 |

**Remove & Replace Entire Ramp.**
