# Access Compliance Report

## Public Rights-of-Way

### (Curb Ramps)

Intersection ID: 52127	Main Street: VALLEYDALE_RD	Cross Street: FRED_D_ALEXANDER_BV	Location: W
ADA ID: 84205FAA6785	Ramp Type: Combination1	Initial Pass/Fail: Fail	Overall Compliance: No
Severity Score: 13.75			
Codes/Mitigation Info/Possible Solution		Field Measurements/Component Compliance

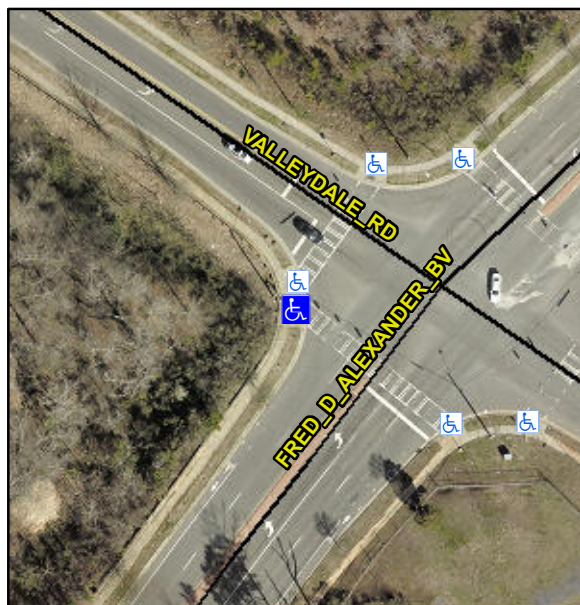
Surveyor Notes:

**RP & RT RP < 5%**

PROW/ADA:

**Not Found, R304.5.3, R304.3.2**

Possible Solutions:

**Remove & Replace Entire Ramp.**
