Access Compliance Report

Public Rights-of-Way

(Curb Ramps)

Intersection ID: 11450	Main Street: GRANDIN_RD	Cross Street: W MARTIN LUTHER KING JR BV	Location: N
ADA ID: 846A338D9D78	Ramp Type: Perp	Initial Pass/Fail: Fail	Overall Compliance: No
			Severity Score: 10

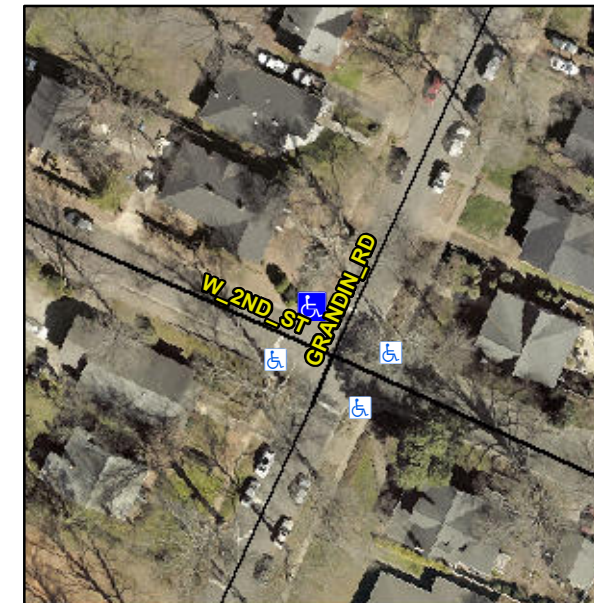
Not Found, R304.5.1, R304.5.3

Compliance	Description	Data	Compliance	Description	Data
N/A	Ramp Length (in)	77.0	Yes	Ramp Slope (%)	7.9
No	Ramp Width (in)	44.0	No	Ramp XSlope (%)	2.6
N/A	Flare Type LT	N/A	N/A	Flare Type RT	N/A
N/A	Flare Slope LT (%)	N/A	N/A	Flare Slope RT (%)	N/A
N/A	Flare Traversable LT?	N/A	N/A	Flare Traversable RT?	N/A
N/A	Landing Length (in)	N/A	N/A	DWS Provided?	N/A
N/A	Landing Width (in)	N/A	N/A	DWS Contrast?	N/A
N/A	Landing Slope (%)	N/A	N/A	DWS Length (in)	N/A
N/A	Landing X Slope (%)	N/A	N/A	DWS Full Width?	N/A
N/A	Landing Curb? (Y/N)	N/A	N/A	DWS Offset (in)	N/A
N/A	Shared Landing?	N/A			
N/A	Gutter Ponding?	N/A	N/A	Gutter Slope (%)	N/A
N/A	Gutter Lip Ht (in)	N/A	N/A	Gutter X Slope (%)	N/A
N/A	Painted X Walk1?	No	N/A	Painted X Walk2?	N/A
	X Walk 1 Direction	To S		X Walk 2 Direction	N/A
N/A	X Walk 1 Width (in)	N/A	N/A	X Walk 2 Width (in)	N/A
	X Walk 1 Slope (%)	3.0		X Walk 2 Slope (%)	N/A
	X Walk 1 X Slope (%)	2.4		X Walk 2 X Slope (%)	N/A

Remove & Replace Entire Ramp.
