# Access Compliance Report

## Public Rights-of-Way

| Intersection ID: 52299 | Main Street: LAKE_VISTA_LN | Cross Street: LINDA_VISTA_LN | Location: W |
| ADA ID: 85082618896A | Ramp Type: PerpDiag | Initial Pass/Fail: Fail | Overall Compliance: No |

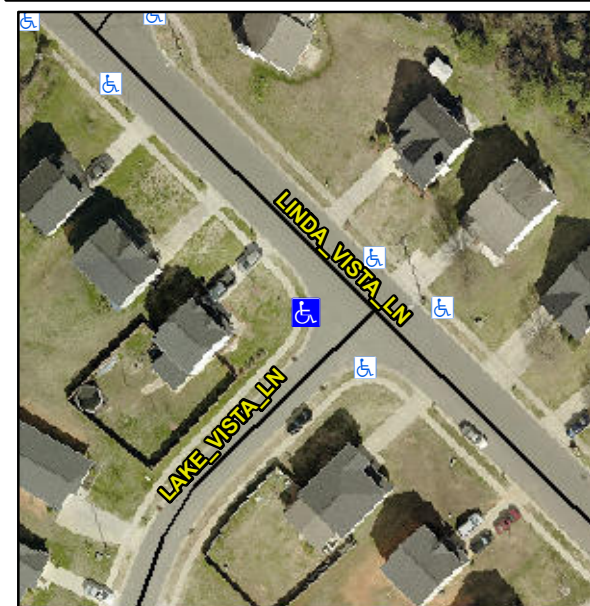
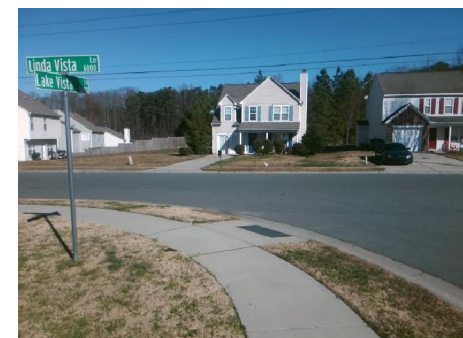
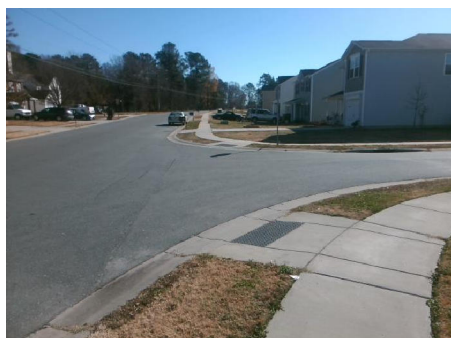
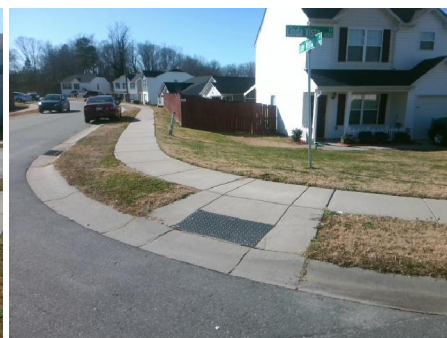
**Not Found, R304.5.1, R304.2.2**

| Compliance | Description | Data | Compliance | Description | Data |
|---|---|---|---|---|---|
| N/A | Ramp Length (in) | 52.0 | No | Ramp Slope (%) | 11.1 |
| No | Ramp Width (in) | 45.0 | Yes | Ramp XSlope (%) | 1.9 |

**Remove & Replace Curb Ramp With Two New Directional Ramps or Equivalent.**
