Access Compliance Report

Public Rights-of-Way

Intersection ID: 24197	Main Street: CHINA GROVE CHURCH RD	Cross Street: ERVIN LN	Location: NW
ADA ID: 85EEB6D53DAC	Ramp Type: PerpDiag	Initial Pass/Fail: Fail	Overall Compliance: No
Codes/Mitigation Info/Possible Solution		Field Measurements/Component Compliance

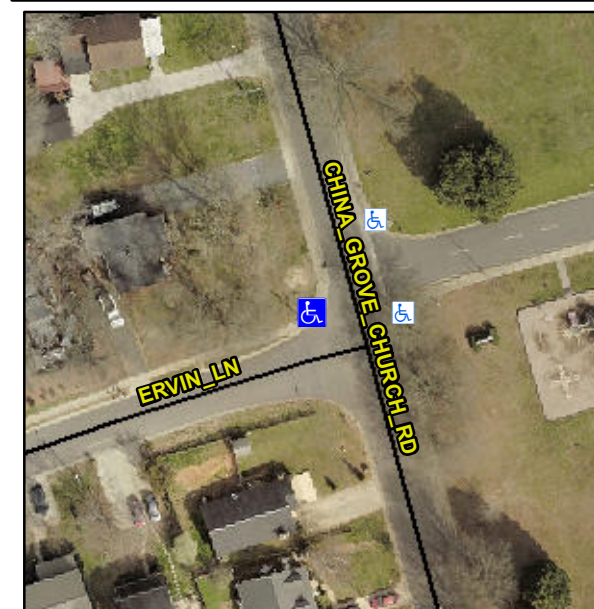
Not Found, R304.5.1, R304.2.2, R304.5.3

Compliance	Description	Data	Compliance	Description	Data
N/A	Ramp Length (in)	48.0	No	Ramp Slope (%)	14.6
No	Ramp Width (in)	38.0	No	Ramp XSlope (%)	8.2
N/A	Flare Type LT	N/A	N/A	Flare Type RT	N/A
N/A	Flare Slope LT (%)	N/A	N/A	Flare Slope RT (%)	N/A
N/A	Flare Traversable LT?	N/A	N/A	Flare Traversable RT?	N/A
N/A	Landing Length (in)	N/A	N/A	DWS Provided?	N/A
N/A	Landing Width (in)	N/A	N/A	DWS Contrast?	N/A
N/A	Landing Slope (%)	N/A	N/A	DWS Length (in)	N/A
N/A	Landing X Slope (%)	N/A	N/A	DWS Full Width?	N/A
N/A	Landing Curb? (Y/N)	N/A	N/A	DWS Offset (in)	N/A
N/A	Shared Landing?	N/A			
N/A	Gutter Ponding?	N/A	N/A	Gutter Slope (%)	N/A
N/A	Gutter Lip Ht (in)	N/A	N/A	Gutter X Slope (%)	N/A
N/A	Painted X Walk1?	No	N/A	Painted X Walk2?	No
	X Walk 1 Direction	To S		X Walk 2 Direction	To NE
N/A	X Walk 1 Width (in)	N/A	N/A	X Walk 2 Width (in)	N/A
	X Walk 1 Slope (%)	1.8		X Walk 2 Slope (%)	2.3
	X Walk 1 X Slope (%)	3.0		X Walk 2 X Slope (%)	1.3

Remove & Replace Curb Ramp With Two New Directional Ramps or Equivalent.
