# Access Compliance Report

## Public Rights-of-Way

### (Curb Ramps)

Intersection ID: 44309	Main Street: LINDA_VISTA_LN	Cross Street: OLIVIA_DIANE_LN	Location: NE
ADA ID: 8604476E60F5	Ramp Type: PerpDiag	Initial Pass/Fail: Fail	Overall Compliance: No
Severity Score: 12.5			
Codes/Mitigation Info/Possible Solution		Field Measurements/Component Compliance

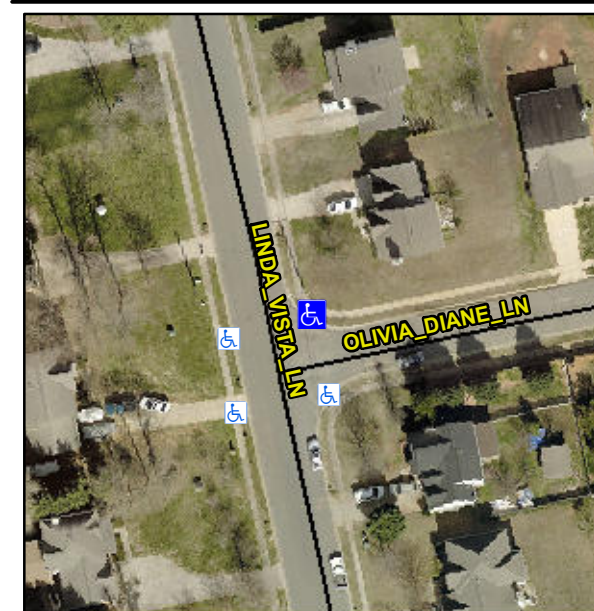
Compliance	Description	Data	Compliance	Description	Data
N/A	Ramp Length (in)	47.0	Yes	Ramp Slope (%)	7.0
Yes	Ramp Width (in)	51.5	No	Ramp XSlope (%)	5.1
N/A	Flare Type LT	N/A	N/A	Flare Type RT	N/A
N/A	Flare Slope LT (%)	N/A	N/A	Flare Slope RT (%)	N/A
N/A	Flare Traversable LT?	N/A	N/A	Flare Traversable RT?	N/A
N/A	Landing Length (in)	N/A	N/A	DWS Provided?	N/A
N/A	Landing Width (in)	N/A	N/A	DWS Contrast?	N/A
N/A	Landing Slope (%)	N/A	N/A	DWS Length (in)	N/A
N/A	Landing X Slope (%)	N/A	N/A	DWS Full Width?	N/A
N/A	Landing Curb? (Y/N)	N/A	N/A	DWS Offset (in)	N/A
N/A	Shared Landing?	N/A			
N/A	Gutter Ponding?	N/A	N/A	Gutter Slope (%)	N/A
N/A	Gutter Lip Ht (in)	N/A	N/A	Gutter X Slope (%)	N/A
N/A	Painted X Walk1?	No	N/A	Painted X Walk2?	No
	X Walk 1 Direction	To W		X Walk 2 Direction	To S
N/A	X Walk 1 Width (in)	N/A	N/A	X Walk 2 Width (in)	N/A
	X Walk 1 Slope (%)	3.3		X Walk 2 Slope (%)	2.5
	X Walk 1 X Slope (%)	1.0		X Walk 2 X Slope (%)	0.1

N/A	Ramp inside XWalk1?	N/A	N/A	Ramp inside XWalk2?	N/A
	Road Slope (%)	0.3	N/A	Clear Space?	N/A
	Road X Slope (%)	3.2	N/A	Clear Space to XWalk (in)	N/A
N/A	Any Obstructions?	N/A	N/A	Storm Grate/Utility Hazard?	N/A
	Obstruction Type			Storm Grate/Utility Type	
		N/A			N/A
			Yes	Surface Condition? (G/P)	Good

Possible Solutions:

**Remove & Replace Curb Ramp With Two New Directional Ramps or Equivalent.**
