Access Compliance Report

Public Rights-of-Way

(Curb Ramps)

| Intersection ID: 52289 | Main Street: TROJAN_DR | Cross Street: DIXIE_RIVER_RD | Location: N |

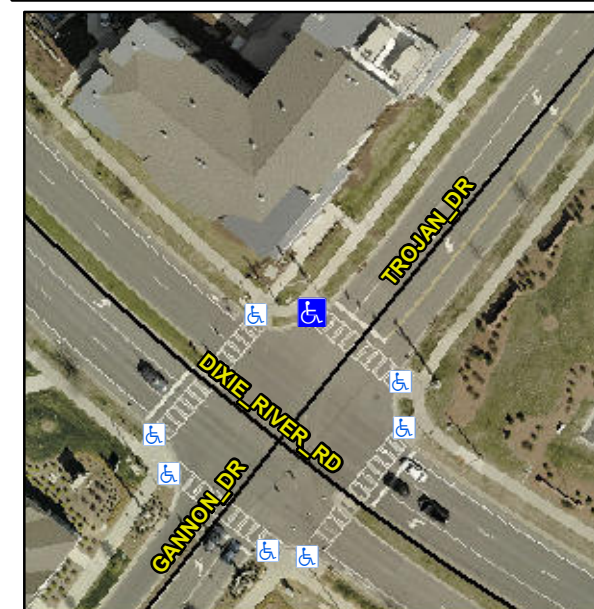
| ADA ID: 8631DB54AB0F | Ramp Type: Perp | Initial Pass/Fail: Fail | Overall Compliance: No |
| Severity Score: 26.25 | | | |

Not Found, R304.2.2, R304.5.3

| Compliance | Description | Data | Compliance | Description | Data |
|---|---|---|---|---|---|
| N/A | Ramp Length (in) | 68.0 | No | Ramp Slope (%) | 12.3 |
| Yes | Ramp Width (in) | 48.0 | No | Ramp XSlope (%) | 3.2 |

Remove & Replace Entire Ramp.
