Access Compliance Report

Public Rights-of-Way

(Curb Ramps)

Intersection ID: 43581	Main Street: LUKES_DR	Cross Street: LINDA_VISTA_LN	Location: E
ADA ID: 869E005D1DC8	Ramp Type: PerpDiag	Initial Pass/Fail: Fail	Overall Compliance: No
Codes/Mitigation Info/Possible Solution		Field Measurements/Component Compliance	
Severity Score: 30

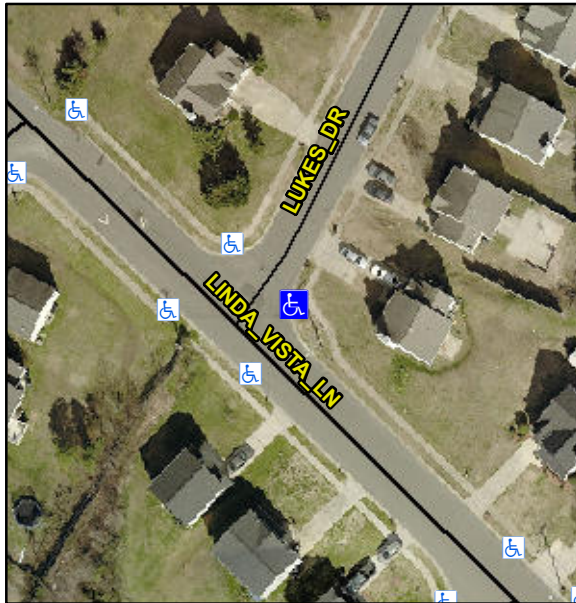
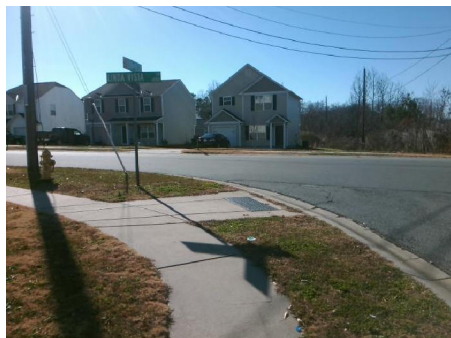
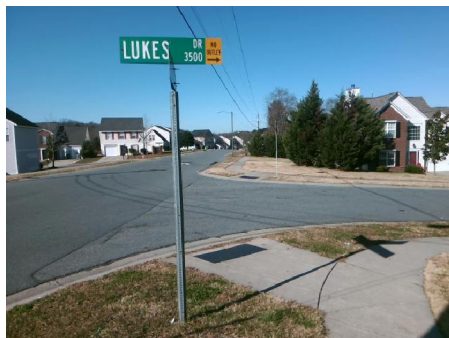
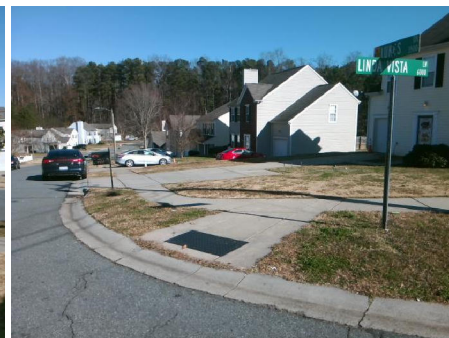
Not Found, R304.5.1, R304.5.3

Compliance	Description	Data	Compliance	Description	Data
N/A	Ramp Length (in)	90.0	Yes	Ramp Slope (%)	5.3
No	Ramp Width (in)	33.0	No	Ramp XSlope (%)	5.5
N/A	Flare Type LT	N/A	N/A	Flare Type RT	N/A
N/A	Flare Slope LT (%)	N/A	N/A	Flare Slope RT (%)	N/A
N/A	Flare Traversable LT?	N/A	N/A	Flare Traversable RT?	N/A
N/A	Landing Length (in)	N/A	N/A	DWS Provided?	N/A
N/A	Landing Width (in)	N/A	N/A	DWS Contrast?	N/A
N/A	Landing Slope (%)	N/A	N/A	DWS Length (in)	N/A
N/A	Landing X Slope (%)	N/A	N/A	DWS Full Width?	N/A
N/A	Landing Curb? (Y/N)	N/A	N/A	DWS Offset (in)	N/A
N/A	Shared Landing?	N/A			
N/A	Gutter Ponding?	N/A	N/A	Gutter Slope (%)	N/A
N/A	Gutter Lip Ht (in)	N/A	N/A	Gutter X Slope (%)	N/A
N/A	Painted X Walk1?	No	N/A	Painted X Walk2?	No
	X Walk 1 Direction	To NW		X Walk 2 Direction	To SW
N/A	X Walk 1 Width (in)	N/A	N/A	X Walk 2 Width (in)	N/A
	X Walk 1 Slope (%)	0.1		X Walk 2 Slope (%)	3.0
	X Walk 1 X Slope (%)	3.6		X Walk 2 X Slope (%)	1.8

N/A	Ramp inside XWalk1?	N/A	N/A	Ramp inside XWalk2?	N/A
	Road Slope (%)	3.2	N/A	Clear Space?	N/A
	Road X Slope (%)	0.3	N/A	Clear Space to XWalk (in)	N/A
N/A	Any Obstructions?	N/A	N/A	Storm Grate/Utility Hazard?	N/A
	Obstruction Type			Storm Grate/Utility Type	
		N/A			N/A
			Yes	Surface Condition? (G/P)	Good

Possible Solutions:

Remove & Replace Curb Ramp With Two New Directional Ramps or Equivalent.
