Access Compliance Report

Public Rights-of-Way

(Curb Ramps)

| Intersection ID: 12310 | Main Street: WEYLAND_AV | Cross Street: GREENLAND_AV | Location: NW |

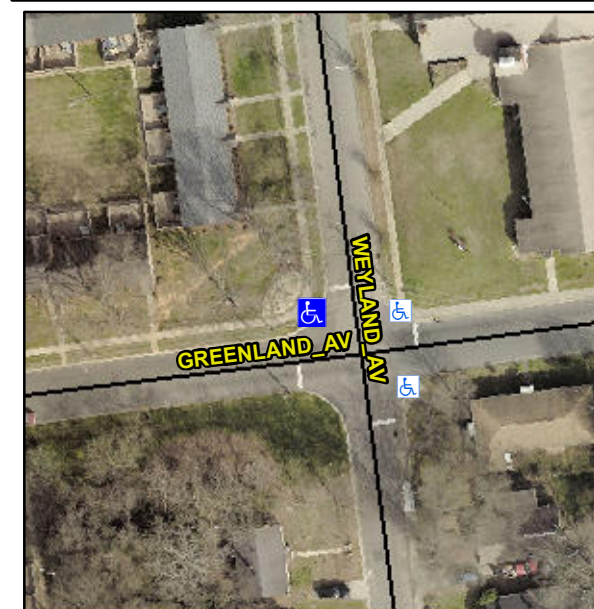
| ADA ID: 87055CEC6A6D | Ramp Type: Perp | Initial Pass/Fail: Fail | Overall Compliance: No |

Not Found, R304.5.1, R304.2.2, R304.5.3

| Compliance | Description | Data | Compliance | Description | Data |
|---|---|---|---|---|---|
| N/A | Ramp Length (in) | 78.0 | No | Ramp Slope (%) | 8.8 |
| No | Ramp Width (in) | 39.0 | No | Ramp XSlope (%) | 5.2 |

Remove & Replace Entire Ramp.
