# Access Compliance Report

## Public Rights-of-Way

### (Curb Ramps)

| Intersection ID: 10025796 | Main Street: EDGEHILL_RD_NORTH | Cross Street: N/A | Location: SE |

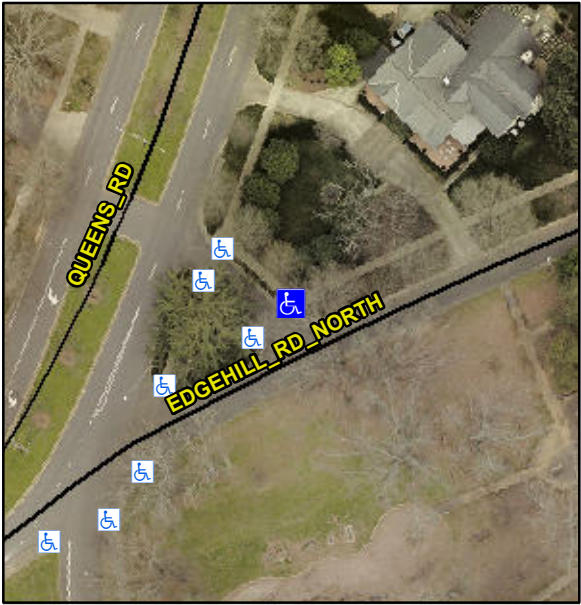
| ADA ID: 87DA79D090F8 | Ramp Type: PerpDiag | Initial Pass/Fail: Fail | Overall Compliance: No |
| Severity Score: 22.5 | | | |

| | Remove & Replace Curb Ramp With Two New Directional Ramps or Equivalent. | N/A | Ramp Length (in) | 63.0 | No | Ramp Slope (%) | 10.8 |
| | | No | Ramp Width (in) | 37.0 | Yes | Ramp XSlope (%) | 4.5 |
| <p>Surveyor Notes:</p> <p>N/A</p> <p>PROW/ADA:</p> <p>Not Found, R304.5.1, R304.2.2</p> | | | Road Slope (%) | 4.5 | N/A | Clear Space? | N/A |
