Access Compliance Report

Public Rights-of-Way

| Intersection ID: 45635 | Main Street: KELSEY_EMMA_CT | Cross Street: MOLLY_ELIZABETH_LN | Location: NW |
| ADA ID: 88056CA3DB2F | Ramp Type: Perp | Initial Pass/Fail: Pass | Overall Compliance: No |

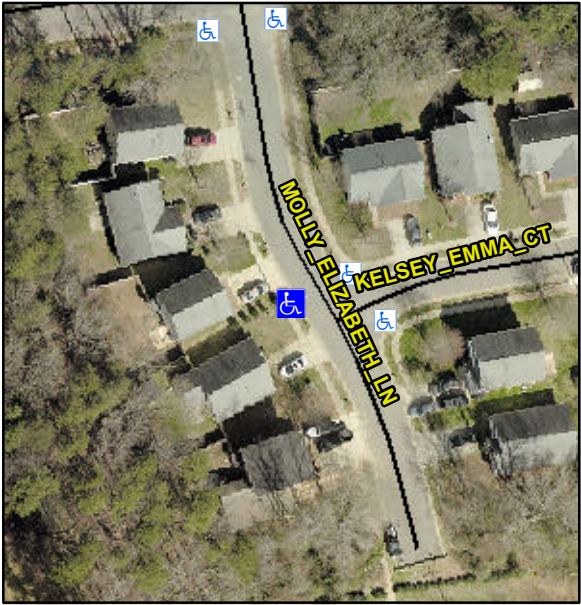
| Codes/Mitigation Info/Possible Solution | | Field Measurements/Component Compliance | | | |
|--|---|---|---|--|--|
| | Not Found, R304.2.2-Perp, R304.3.2-Para, R305, R304.5.4 | | | | |

| Compliance | Description | Data | Compliance | Description | Data |
|---|---|---|---|---|---|
| Yes | Landing Length (in) | 48.0 | No | DWS Provided? | No |
| No | Landing Slope (%) | 2.8 | N/A | DWS Length (in) | N/A |
| Yes | Gutter Ponding? | No | No | Gutter Slope (%) | 8.1 |

| Codes/Mitigation Info/Possible Solution | | Field Measurements/Component Compliance | | | |
|--|---|---|---|--|--|
| | Remove & Replace Entire Ramp. | | | | |
| | Remove & Replace Gutter. | | | | |
