Access Compliance Report

Public Rights-of-Way

| Intersection ID: 19817 | Main Street: MONROE_RD | Cross Street: TIMBER_SPRINGS_DR | Location: SE |
| ADA ID: 8830A41AEF57 | Ramp Type: Para | Initial Pass/Fail: Fail | Overall Compliance: No |

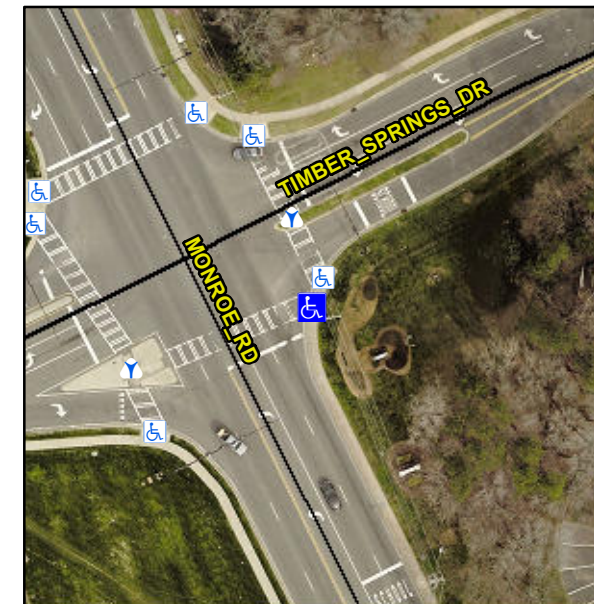
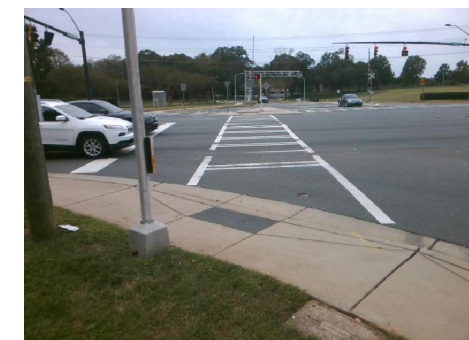
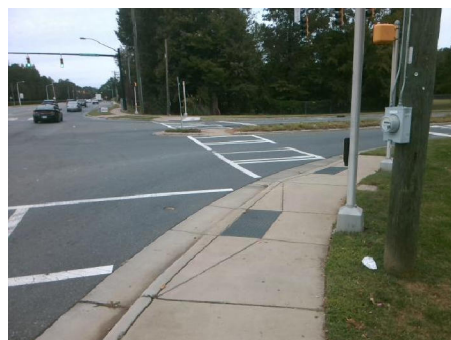
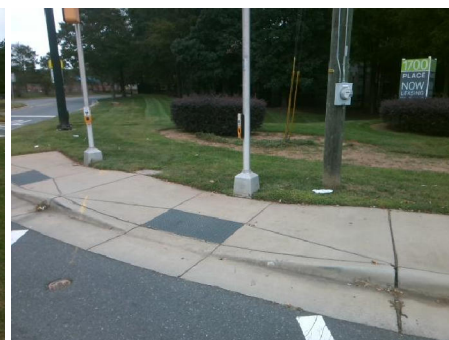
| Severity Score: 33.75 | | | |

R304.5.1, R304.5.3, R304.3.2

| Compliance | Description | Data | Compliance | Description | Data |
|---|---|---|---|---|---|
| No | Ramp Width LT (in) | 36.0 | No | Ramp Width RT (in) | 36.0 |
| Yes | Ramp Slope LT (%) | 5.1 | No | Ramp Slope RT (%) | 8.9 |
| No | Ramp XSlope LT (%) | 4.1 | No | Ramp XSlope RT (%) | 5.1 |

Remove & Replace Entire Ramp.
