Access Compliance Report Public Rights-of-Way (Curb Ramps)

Intersection ID: 10033070 Main Street: NORTH_COMMUNITY_HOUSE_& Street: N/A Location: Е

Overall Compliance: No **Severity Score:** ADA ID: 884413CF14D5 Ramp Type: Perp Initial Pass/Fail: Pass 5

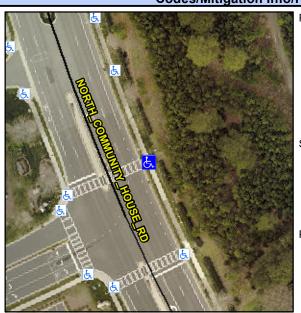
| 1 033IDIE OOIGHOH | |
|---|---|
| Not Found, R304.5.4, R304.5.3 | ` |

| Field Measurements/Component Compliance | | | | | | | | |
|---|---|---|---|---|---|--|--|--|
| Yes | Gutter Ponding? | No | No | Gutter Slope (%) | 7.4 | | | |
| Yes | Gutter Lip Ht (in) | 0.0 | No | Gutter X Slope (%) | 3.5 | | | |

| 1 033IDIE OOIGHOH | |
|---|---|
| Remove & Replace Entire Ramp. | ı |
| Remove & Replace Gutter. | • |
