# Access Compliance Report

## Public Rights-of-Way

### (Curb Ramps)

Intersection ID: 28313	Main Street: ALBURY_WALK_LN	Cross Street: HANWORTH_TRACE_DR	Location: NE
ADA ID: 886FC98BB420	Ramp Type: Perp	Initial Pass/Fail: Fail	Overall Compliance: No
Codes/Mitigation Info/Possible Solution		Field Measurements/Component Compliance	
Severity Score: 13.75

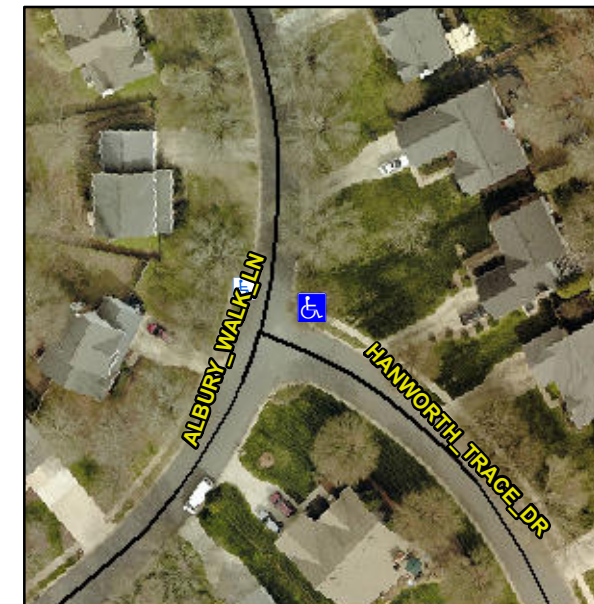
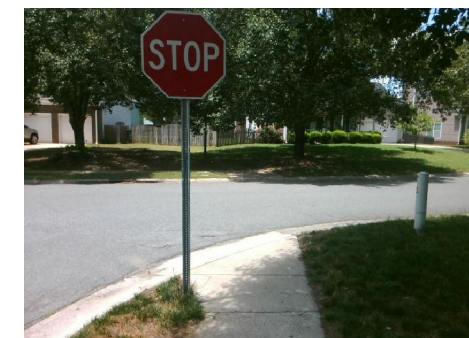
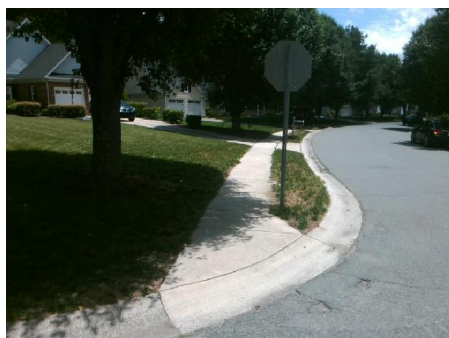
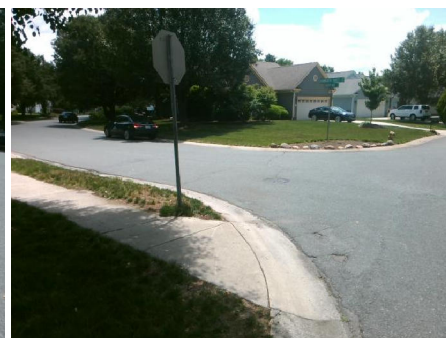
**Not Found, R304.2.2, R304.5.3**

Compliance	Description	Data	Compliance	Description	Data
N/A	Ramp Length (in)	54.0	No	Ramp Slope (%)	9.8
Yes	Ramp Width (in)	96.0	No	Ramp XSlope (%)	3.6
N/A	Flare Type LT	N/A	N/A	Flare Type RT	N/A
N/A	Flare Slope LT (%)	N/A	N/A	Flare Slope RT (%)	N/A
N/A	Flare Traversable LT?	N/A	N/A	Flare Traversable RT?	N/A
N/A	Landing Length (in)	N/A	N/A	DWS Provided?	N/A
N/A	Landing Width (in)	N/A	N/A	DWS Contrast?	N/A
N/A	Landing Slope (%)	N/A	N/A	DWS Length (in)	N/A
N/A	Landing X Slope (%)	N/A	N/A	DWS Full Width?	N/A
N/A	Landing Curb? (Y/N)	N/A	N/A	DWS Offset (in)	N/A
N/A	Shared Landing?	N/A			
N/A	Gutter Ponding?	N/A	N/A	Gutter Slope (%)	N/A
N/A	Gutter Lip Ht (in)	N/A	N/A	Gutter X Slope (%)	N/A
N/A	Painted X Walk1?	No	N/A	Painted X Walk2?	N/A
	X Walk 1 Direction	To NW		X Walk 2 Direction	N/A
N/A	X Walk 1 Width (in)	N/A	N/A	X Walk 2 Width (in)	N/A
	X Walk 1 Slope (%)	5.5		X Walk 2 Slope (%)	N/A
	X Walk 1 X Slope (%)	0.8		X Walk 2 X Slope (%)	N/A

N/A	Ramp inside XWalk1?	N/A	N/A	Ramp inside XWalk2?	N/A
	Road Slope (%)	1.4	N/A	Clear Space?	N/A
	Road X Slope (%)	2.4	N/A	Clear Space to XWalk (in)	N/A
N/A	Any Obstructions?	N/A	N/A	Storm Grate/Utility Hazard?	N/A
	Obstruction Type			Storm Grate/Utility Type	
		N/A			N/A
			Yes	Surface Condition? (G/P)	Good

**Remove & Replace Entire Ramp.**
