# Access Compliance Report

## Public Rights-of-Way

### (Curb Ramps)

Intersection ID: 31553	Main Street: CALDWELL_RD	Cross Street: CALDWELL_RIDGE_PY	Location: E
ADA ID: 8889FDBA4DB1	Ramp Type: Combination1	Initial Pass/Fail: Fail	Overall Compliance: No
		Severity Score: 8.75

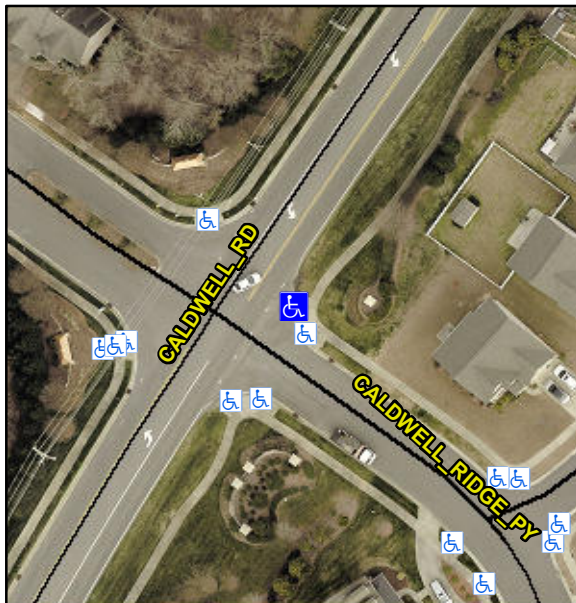
**LT RP < 5%**

**Not Found, R304.5.1**

**Remove & Replace Entire Ramp.**
