Access Compliance Report

Public Rights-of-Way (Curb Ramps)

Intersection ID: 8283	Main Street: DRURY_DR	Cross Street: W_CRAIGHEAD_RD	Location: SW
ADA ID: 88B0FFBC2255	Ramp Type: Combination2	Initial Pass/Fail: Fail	Overall Compliance: No
		Severity Score: 10

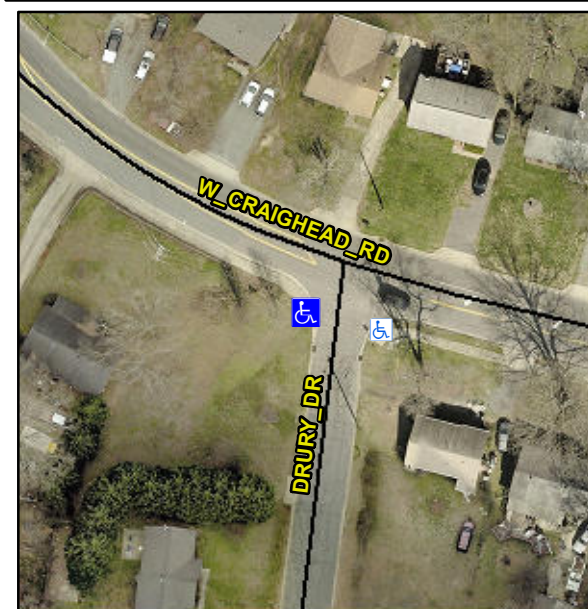
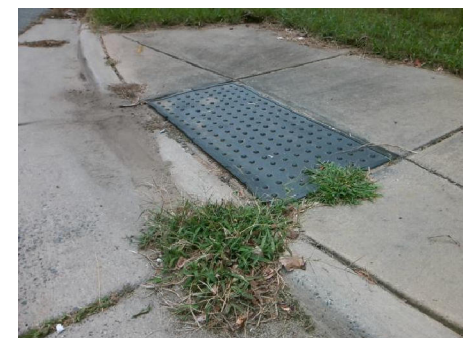
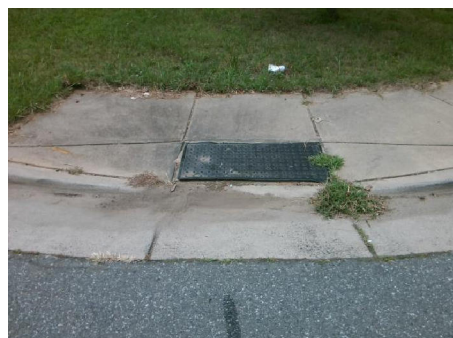
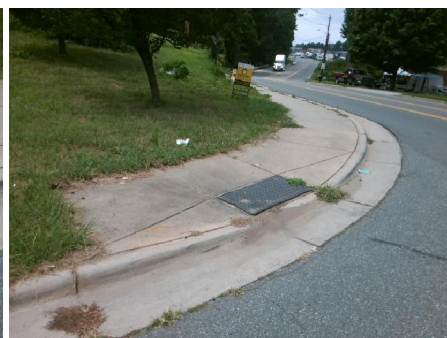
LT RP < 5%

Not Found, R304.5.1, R304.5.1

Compliance	Description	Data	Compliance	Description	Data
N/A	Ramp Length LT (in)	55.0	N/A	Ramp Length RT (in)	49.0
N/A	Ramp Width LT (in)	47.5	No	Ramp Width RT (in)	46.0
N/A	Ramp Slope LT (%)	4.2	Yes	Ramp Slope RT (%)	7.4
N/A	Ramp XSlope LT (%)	4.2	Yes	Ramp XSlope RT (%)	0.7
N/A	Ramp Length (in)	25.0	Yes	Ramp Slope (%)	4.3
No	Ramp Width (in)	47.0	Yes	Ramp XSlope (%)	0.4
N/A	Flare Type LT	N/A	N/A	Flare Type RT	N/A
N/A	Flare Slope LT (%)	N/A	N/A	Flare Slope RT (%)	N/A
N/A	Flare Traversable LT?	N/A	N/A	Flare Traversable RT?	N/A
N/A	Landing Length (in)	N/A	N/A	DWS Provided?	N/A
N/A	Landing Width (in)	N/A	N/A	DWS Contrast?	N/A
N/A	Landing Slope (%)	N/A	N/A	DWS Length (in)	N/A
N/A	Landing X Slope (%)	N/A	N/A	DWS Full Width?	N/A
N/A	Landing Curb? (Y/N)	N/A	N/A	DWS Offset (in)	N/A
N/A	Shared Landing?	N/A			
N/A	Gutter Ponding?	N/A	N/A	Gutter Slope (%)	N/A
N/A	Gutter Lip Ht (in)	N/A	N/A	Gutter X Slope (%)	N/A
N/A	Painted X Walk1?	No	N/A	Painted X Walk2?	N/A

Remove & Replace Entire Ramp.
