## **Access Compliance Report Public Rights-of-Way** (Curb Ramps)

Intersection ID: 10147 Main Street: E\_27TH\_ST Cross Street: N\_TRYON\_ST Location: SE ADA ID: 88DBB3C8E294 Ramp Type: Perp Initial Pass/Fail: Fail **Overall Compliance: No** Severity Score: 33.75

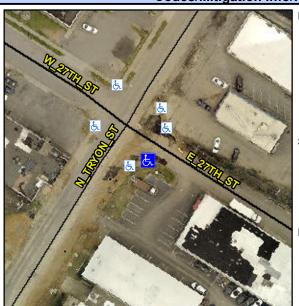
W 27TH ST Street 1 Name Stop Condition-Street 2 StopSign Street 2 Name N/A Stop Condition-Street 1 N/A Possible Solutions: Remove & Replace Entire Ramp. Surveyor Notes: N/A PROW/ADA: Not Found, R304.5.1, R304.2.2

| Field Measurements/Component Compliance | | | | | |
|---|---|---|---|---|---|
| N/A | Ramp Length (in) | 60.0 | No | Ramp Slope (%) | 12.5 |
| No | Ramp Width (in) | 47.5 | Yes | Ramp XSlope (%) | 2.0 |
