# Access Compliance Report

## Public Rights-of-Way

### (Curb Ramps)

| Intersection ID: 10862 | Main Street: N_GRAHAM_ST | Cross Street: DALTON_AV | Location: SE |

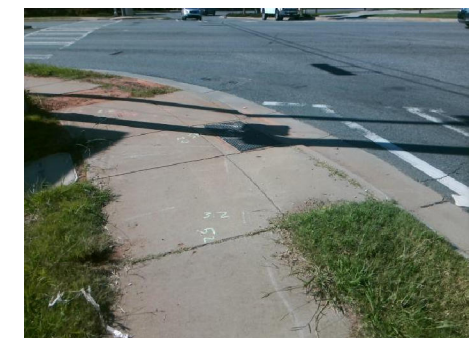
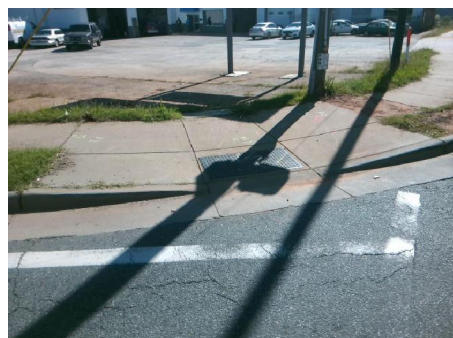
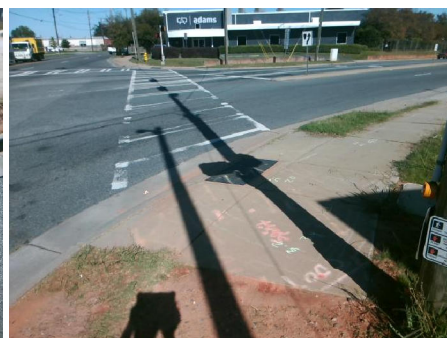
**RT RP < 5%**

**Not Found, R304.5.3, R304.2.1,  
R304.2.2-Perp, R304.3.2-Para,  
R305.1.4, R305.2**

| Compliance | Description | Data | Compliance | Description | Data |
|---|---|---|---|---|---|
| No | Ramp XSlope LT (%) | 3.2 | No | Ramp XSlope RT (%) | 3.2 |
| No | Landing Width (in) | 43.0 | Yes | DWS Contrast? | Yes |
| No | Landing Slope (%) | 3.1 | Yes | DWS Length (in) | 25.0 |
| Yes | Landing X Slope (%) | 0.4 | No | DWS Full Width? | No |
| N/A | Landing Curb? (Y/N) | No | No | DWS Offset (in) | 3.0 |

**Remove & Replace Entire Ramp.  
Remove & Replace Sidewalk.**
