Access Compliance Report

Public Rights-of-Way

(Curb Ramps)

Intersection ID: 53962	Main Street: LILAC_TREE_AV	Cross Street: DENBUR_DR	Location: W
ADA ID: 89180EDE0DBB	Ramp Type: Combination2	Initial Pass/Fail: Fail	Overall Compliance: No
Severity Score: 10			
Codes/Mitigation Info/Possible Solution		Field Measurements/Component Compliance

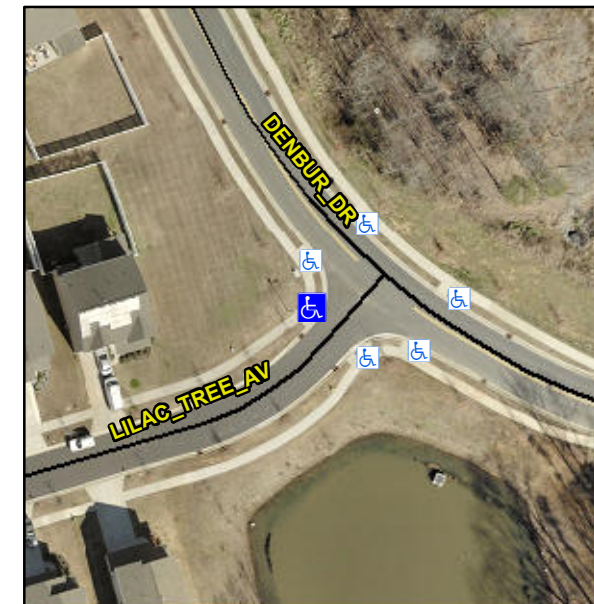
RT RP < 5%

Not Found, R304.5.1, R304.5.3

Compliance	Description	Data	Compliance	Description	Data
N/A	Ramp Length LT (in)	55.0	N/A	Ramp Length RT (in)	37.0
Yes	Ramp Width LT (in)	60.0	N/A	Ramp Width RT (in)	60.0
Yes	Ramp Slope LT (%)	6.8	N/A	Ramp Slope RT (%)	1.5
Yes	Ramp XSlope LT (%)	1.8	N/A	Ramp XSlope RT (%)	0.8
N/A	Ramp Length (in)	48.0	Yes	Ramp Slope (%)	4.6
No	Ramp Width (in)	47.5	No	Ramp XSlope (%)	3.7
N/A	Flare Type LT	N/A	N/A	Flare Type RT	N/A
N/A	Flare Slope LT (%)	N/A	N/A	Flare Slope RT (%)	N/A
N/A	Flare Traversable LT?	N/A	N/A	Flare Traversable RT?	N/A
N/A	Landing Length (in)	N/A	N/A	DWS Provided?	N/A
N/A	Landing Width (in)	N/A	N/A	DWS Contrast?	N/A
N/A	Landing Slope (%)	N/A	N/A	DWS Length (in)	N/A
N/A	Landing X Slope (%)	N/A	N/A	DWS Full Width?	N/A
N/A	Landing Curb? (Y/N)	N/A	N/A	DWS Offset (in)	N/A
N/A	Shared Landing?	N/A			
N/A	Gutter Ponding?	N/A	N/A	Gutter Slope (%)	N/A
N/A	Gutter Lip Ht (in)	N/A	N/A	Gutter X Slope (%)	N/A
N/A	Painted X Walk1?	No	N/A	Painted X Walk2?	N/A

Remove & Replace Entire Ramp.

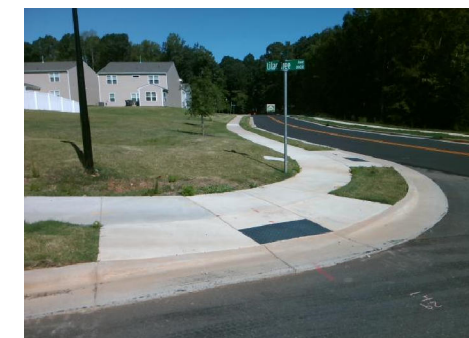
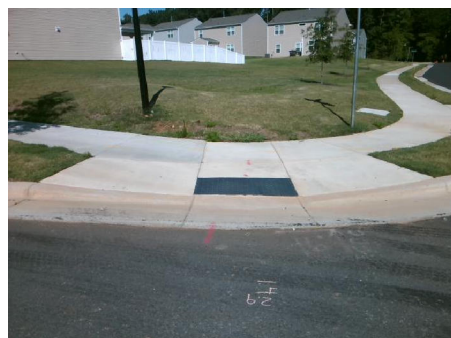
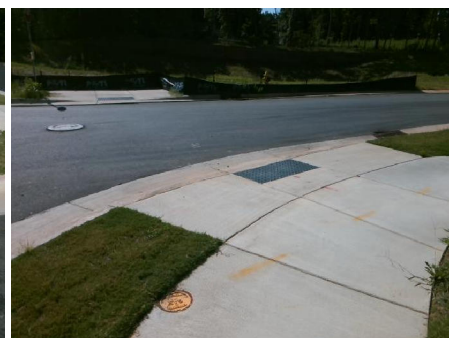
X Walk 1 Direction	To SE		X Walk 2 Direction	N/A
	X Walk 1 Width (in)	N/A		X Walk 2 Width (in)	N/A
	X Walk 1 Slope (%)	1.4		X Walk 2 Slope (%)	N/A
	X Walk 1 X Slope (%)	2.9		X Walk 2 X Slope (%)	N/A
N/A	Ramp inside XWalk1?	N/A	N/A	Ramp inside XWalk2?	N/A
	Road Slope (%)	N/A		Clear Space?	N/A
	Road X Slope (%)	N/A	N/A	Clear Space to XWalk (in)	N/A
			N/A	Any Obstruction?	N/A
				Obstruction Type	N/A
			N/A	Storm Grate/Utility Hazard?	N/A
				Storm Grate/Utility Type	N/A
			Yes	Surface Condition? (G/P)	Good
				Curb Slope (%)	10.4
