Access Compliance Report

Public Rights-of-Way

(Curb Ramps)

Intersection ID: 50321	Main Street: BELMAR_PLACE_RD	Cross Street: CINDY_LN	Location: NW
ADA ID: 891D91EB5680	Ramp Type: Directional1	Initial Pass/Fail: Fail	Overall Compliance: No
		Severity Score: 25

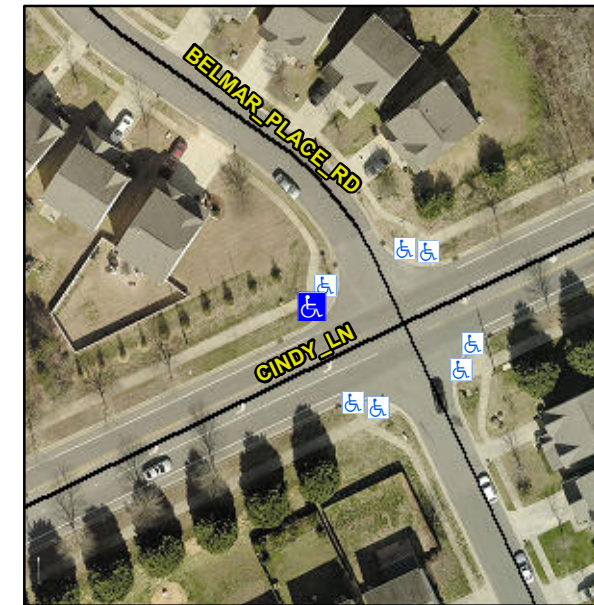
R304.2.2, R304.5.3

Compliance	Description	Data	Compliance	Description	Data
N/A	Ramp Length (in)	59.0	N/A	Grade Break?	N/A
Yes	Ramp Width (in)	63.0	N/A	Grade Break Slope (%)	0.0
No	Ramp Slope (%)	8.9	N/A	Grade Break XSlope (%)	0.0
No	Ramp XSlope (%)	6.7			
N/A	Flare Type LT	N/A	N/A	Flare Type RT	N/A
N/A	Flare Slope LT (%)	N/A	N/A	Flare Slope RT (%)	0.0
N/A	Flare Traversable LT?	N/A	N/A	Flare Traversable RT?	N/A
N/A	Landing Length (in)	0.0	N/A	DWS Provided?	N/A
N/A	Landing Width (in)	0.0	N/A	DWS Contrast?	N/A
N/A	Landing Slope (%)	0.0	N/A	DWS Length (in)	N/A
N/A	Landing X Slope (%)	0.0	N/A	DWS Full Width?	N/A
N/A	Landing Curb? (Y/N)	N/A	N/A	DWS Offset LT (in)	N/A
N/A	Shared Landing?	N/A	N/A	DWS Offset RT (in)	N/A
N/A	Gutter Ponding?	0.0	N/A	Gutter Slope (%)	N/A
N/A	Gutter Lip Ht (in)	0.0	N/A	Gutter X Slope (%)	N/A
N/A	Painted X Walk1?	No		Road Slope (%)	4.4
	X Walk 1 Direction	To S		Road X Slope (%)	2.3
	X Walk 1 Width (in)	N/A		Clear Space?	N/A

X Walk 1 Slope (%)	4.4	N/A	Clear Space to XWalk (in)	N/A
	X Walk 1 X Slope (%)	2.3	N/A	Storm Grate/Utility Hazard?	N/A
N/A	Ramp inside XWalk1?	N/A		Storm Grate/Utility Type	
N/A	Any Obstructions?	N/A			N/A
	Obstruction Type		Yes	Surface Condition? (G/P)	Good
			N/A	Curb Slope (%)	N/A

Remove & Replace Entire Ramp.
