# Access Compliance Report

## Public Rights-of-Way

### (Curb Ramps)

Intersection ID: 9731	Main Street: BANCROFT_ST	Cross Street: CONCORDIA_AV	Location: S
ADA ID: 8928FE3575BC	Ramp Type: Combination2	Initial Pass/Fail: Fail	Overall Compliance: No
		Severity Score: 72.5

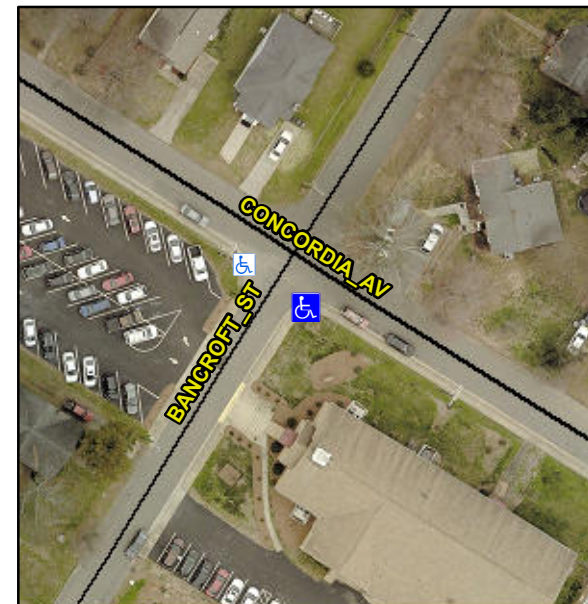
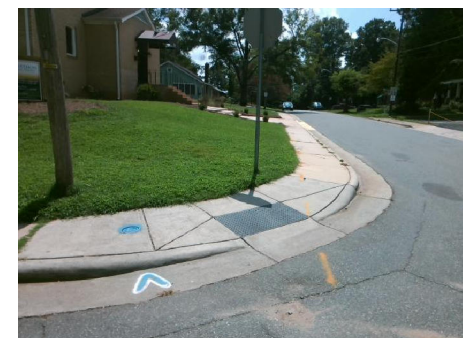
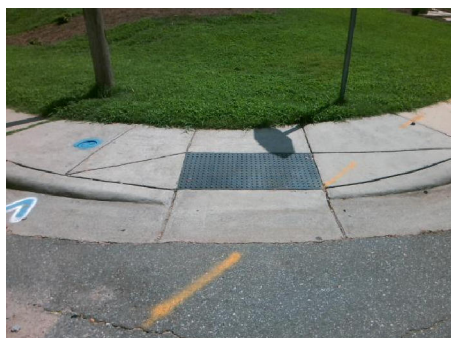
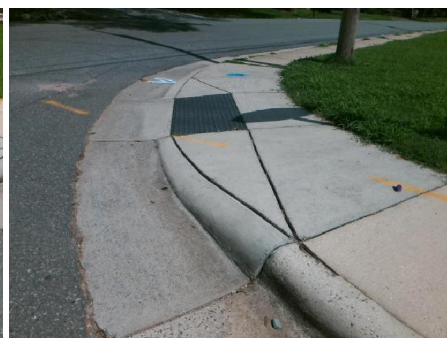
**LT RP < 5%**

**Not Found, R304.5.1, R304.2.2, R304.5.3**

Compliance	Description	Data	Compliance	Description	Data
N/A	Ramp Length LT (in)	28.0	N/A	Ramp Length RT (in)	46.0
N/A	Ramp Width LT (in)	28.0	No	Ramp Width RT (in)	32.0
N/A	Ramp Slope LT (%)	2.2	Yes	Ramp Slope RT (%)	8.3
N/A	Ramp XSlope LT (%)	10.3	No	Ramp XSlope RT (%)	3.2
N/A	Ramp Length (in)	57.0	No	Ramp Slope (%)	11.9
Yes	Ramp Width (in)	48.0	No	Ramp XSlope (%)	3.5
N/A	Flare Type LT	N/A	N/A	Flare Type RT	N/A
N/A	Flare Slope LT (%)	N/A	N/A	Flare Slope RT (%)	N/A
N/A	Flare Traversable LT?	N/A	N/A	Flare Traversable RT?	N/A
N/A	Landing Length (in)	N/A	N/A	DWS Provided?	N/A
N/A	Landing Width (in)	N/A	N/A	DWS Contrast?	N/A
N/A	Landing Slope (%)	N/A	N/A	DWS Length (in)	N/A
N/A	Landing X Slope (%)	N/A	N/A	DWS Full Width?	N/A
N/A	Landing Curb? (Y/N)	N/A	N/A	DWS Offset (in)	N/A
N/A	Shared Landing?	N/A			
N/A	Gutter Ponding?	N/A	N/A	Gutter Slope (%)	N/A
N/A	Gutter Lip Ht (in)	N/A	N/A	Gutter X Slope (%)	N/A
N/A	Painted X Walk1?	No	N/A	Painted X Walk2?	N/A

**Remove & Replace Entire Ramp.**
