Access Compliance Report

Public Rights-of-Way

(Curb Ramps)

Intersection ID: 5827	Main Street: ST_JOSEPH_DR	Cross Street: OLSEN_LN	Location:	E
ADA ID: 896080A66573	Ramp Type: Perp	Initial Pass/Fail: Fail	Overall Compliance: No	Severity Score: 35

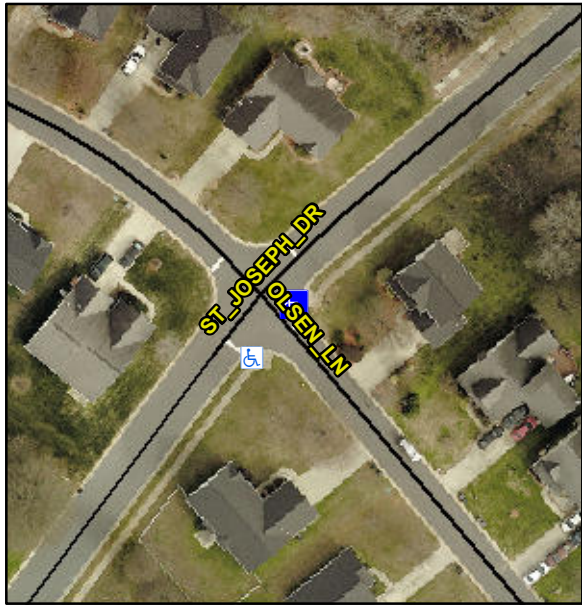
Possible Solutions:		Compliance	Description	Data	Compliance	Description	Data
	Remove & Replace Entire Ramp.		N/A	Ramp Length (in)	48.0	Yes	Ramp Slope (%)	5.1
			No	Ramp Width (in)	31.5	Yes	Ramp XSlope (%)	0.5
			N/A	Flare Type LT	N/A	N/A	Flare Type RT	N/A
			N/A	Flare Slope LT (%)	N/A	N/A	Flare Slope RT (%)	N/A
			N/A	Flare Traversable LT?	N/A	N/A	Flare Traversable RT?	N/A
			N/A	Landing Length (in)	N/A	N/A	DWS Provided?	N/A
			N/A	Landing Width (in)	N/A	N/A	DWS Contrast?	N/A
			N/A	Landing Slope (%)	N/A	N/A	DWS Length (in)	N/A
			N/A	Landing X Slope (%)	N/A	N/A	DWS Full Width?	N/A
Surveyor Notes: N/A PROW/ADA: Not Found, R304.5.1			N/A	Landing Curb? (Y/N)	N/A	N/A	DWS Offset (in)	N/A
			N/A	Shared Landing?	N/A			
			N/A	Gutter Ponding?	N/A	N/A	Gutter Slope (%)	N/A
			N/A	Gutter Lip Ht (in)	N/A	N/A	Gutter X Slope (%)	N/A

N/A	Painted X Walk1?	No	N/A	Painted X Walk2?	N/A
				X Walk 1 Direction	To S		X Walk 2 Direction	N/A
			N/A	X Walk 1 Width (in)	N/A	N/A	X Walk 2 Width (in)	N/A
				X Walk 1 Slope (%)	2.0		X Walk 2 Slope (%)	N/A
				X Walk 1 X Slope (%)	4.5		X Walk 2 X Slope (%)	N/A
			N/A	Ramp inside XWalk1?	N/A	N/A	Ramp inside XWalk2?	N/A
			Road Slope (%)	N/A	N/A	Clear Space?	N/A	
			Road X Slope (%)	N/A	N/A	Clear Space to XWalk (in)	N/A	
		N/A	Any Obstructions?	N/A	N/A	Storm Grate/Utility Hazard?	N/A	
			Obstruction Type			Storm Grate/Utility Type		
					N/A			N/A
						Yes	Surface Condition? (G/P)	Good
