Access Compliance Report

Public Rights-of-Way

(Curb Ramps)

Intersection ID: 11049	Main Street: MALTA_PL	Cross Street: OAK_FOREST_DR	Location: N
ADA ID: 89810C329683	Ramp Type: ParaDiag	Initial Pass/Fail: Fail	Overall Compliance: No
			Severity Score: 26.25

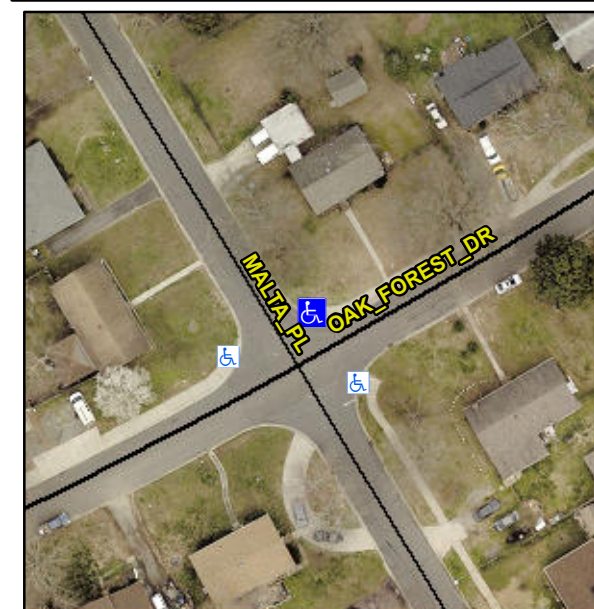
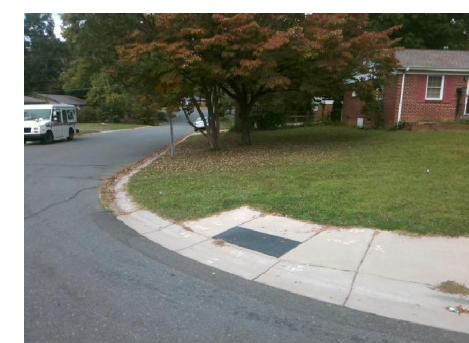
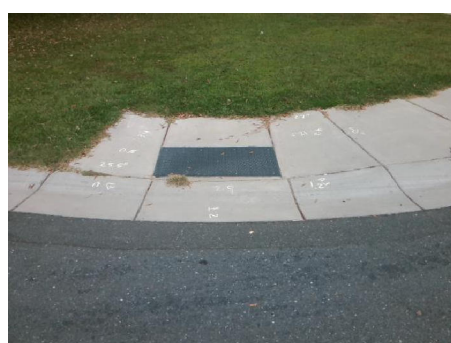
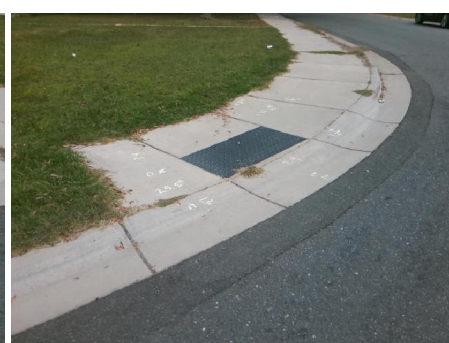
LT RP < 5%

R304.5.3, R304.3.2

Compliance	Description	Data	Compliance	Description	Data
N/A	Ramp Length LT (in)	25.5	N/A	Ramp Length RT (in)	27.0
Yes	Ramp Width LT (in)	60.0	Yes	Ramp Width RT (in)	60.0
Yes	Ramp Slope LT (%)	0.8	No	Ramp Slope RT (%)	12.3
No	Ramp XSlope LT (%)	3.4	No	Ramp XSlope RT (%)	4.2
N/A	Landing Length (in)	N/A	N/A	DWS Provided?	N/A
N/A	Landing Width (in)	N/A	N/A	DWS Contrast?	N/A
N/A	Landing Slope (%)	N/A	N/A	DWS Length (in)	N/A
N/A	Landing X Slope (%)	N/A	N/A	DWS Full Width?	N/A
N/A	Landing Curb? (Y/N)	N/A	N/A	DWS Offset (in)	N/A
N/A	Shared Landing?	N/A			
N/A	Gutter Ponding?	N/A	N/A	Gutter Slope (%)	N/A
N/A	Gutter Lip Ht (in)	N/A	N/A	Gutter X Slope (%)	N/A
N/A	Painted X Walk1?	No	N/A	Painted X Walk2?	No
	X Walk 1 Direction	To SW		X Walk 2 Direction	To SE
N/A	X Walk 1 Width (in)	N/A	N/A	X Walk 2 Width (in)	N/A
	X Walk 1 Slope (%)	1.4		X Walk 2 Slope (%)	0.3
	X Walk 1 X Slope (%)	1.3		X Walk 2 X Slope (%)	1.2
N/A	Ramp inside XWalk1?	N/A	N/A	Ramp inside XWalk2?	N/A

Remove & Replace Curb Ramp With Two New Directional Ramps or Equivalent.
