Access Compliance Report Public Rights-of-Way (Curb Ramps)

Intersection ID: 8515Main Street: ATANDO_AVCross Street: STATESVILLE_AVLocation: SWADA ID: 89AC4F6BBB39Ramp Type: PerpInitial Pass/Fail: Fail Overall Compliance: No Severity Score: 31.25

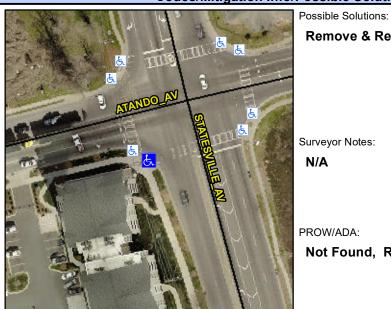
Field Measurements/Component Compliance									
Comp	liance Description	Data	Compl	iance Description	Data				
N/A	Ramp Length (in)	138.0	No	Ramp Slope (%)	11.1				
No	Ramp Width (in)	34.0	Yes	Ramp XSlope (%)	3.5				
N/A	Flare Type LT	N/A	N/A	Flare Type RT	N/A				
N/A	Flare Slope LT (%)	N/A	N/A	Flare Slope RT (%)	N/A				
N/A	Flare Traversable LT?	N/A	N/A	Flare Traversable RT?	N/A				
N/A	Landing Length (in)	N/A	N/A	DWS Provided?	N/A				
N/A	Landing Width (in)	N/A	N/A	DWS Contrast?	N/A				
N/A	Landing Slope (%)	N/A	N/A	DWS Length (in)	N/A				
N/A	Landing X Slope (%)	N/A	N/A	DWS Full Width?	N/A				
N/A	Landing Curb? (Y/N)	N/A	N/A	DWS Offset (in)	N/A				
N/A	Shared Landing?	N/A							
N/A	Gutter Ponding?	N/A	N/A	Gutter Slope (%)	N/A				
N/A	Gutter Lip Ht (in)	N/A	N/A	Gutter X Slope (%)	N/A				
N/A	Painted X Walk1?	Yes	N/A	Painted X Walk2?	N/A				
	X Walk 1 Direction	То Е		X Walk 2 Direction	N/A				
N/A	X Walk 1 Width (in)	107.0	N/A	X Walk 2 Width (in)	N/A

Pomovo & Ponlaco Entiro Pama			
Remove & Replace Entire Ramp.	N N		
	N		
	N		
	N		
	N		
Surveyor Notes:	N		
N/A	N		
	N		
	N		
	N		
PROW/ADA:	N		
Not Found, R304.5.1, R304.2.2	N		
Not 1 Julia, 1304.5.1, 1304.2.2	N		
	N		
	N		
	N
