Access Compliance Report Public Rights-of-Way (Curb Ramps)

Intersection ID: 5758 Main Street: NEVIN_RD Cross Street: SPANISH_MOSS_LN Location: S

ADA ID: 89EE4BD02DBD Ramp Type: Perp Initial Pass/Fail: Fail Overall Compliance: No Severity Score: 1.25

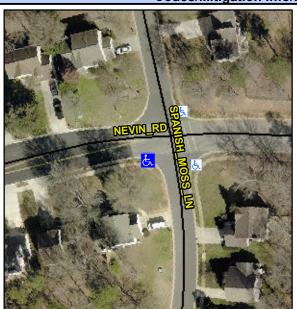
Field Measurements/Component Compliance						
Compliance Description		Data	Comp	oliance Description	Data	
N/A	Ramp Length (in)	96.0	Yes	Ramp Slope (%)	5.1	
Yes	Ramp Width (in)	48.0	No	Ramp XSlope (%)	3.9	
N/A	Flare Type LT	N/A	N/A	Flare Type RT	N/A	
N/A	Flare Slope LT (%)	N/A	N/A	Flare Slope RT (%)	N/A	
N/A	Flare Traversable LT?	N/A	N/A	Flare Traversable RT?	N/A	
N/A	Landing Length (in)	N/A	N/A	DWS Provided?	N/A	
N/A	Landing Width (in)	N/A	N/A	DWS Contrast?	N/A	
N/A	Landing Slope (%)	N/A	N/A	DWS Length (in)	N/A	
N/A	Landing X Slope (%)	N/A	N/A	DWS Full Width?	N/A	
N/A	Landing Curb? (Y/N)	N/A	N/A	DWS Offset (in)	N/A	
N/A	Shared Landing?	N/A				
N/A	Gutter Ponding?	N/A	N/A	Gutter Slope (%)	N/A	
N/A	Gutter Lip Ht (in)	N/A	N/A	Gutter X Slope (%)	N/A	
N/A	Painted X Walk1?	No	N/A	Painted X Walk2?	N/A	
	X Walk 1 Direction	To E		X Walk 2 Direction	N/A	
N/A	X Walk 1 Width (in)	N/A	N/A	X Walk 2 Width (in)	N/A	
	X Walk 1 Slope (%)	3.6		X Walk 2 Slope (%)	N/A

X Walk 1 X Slope (%)	6.4		X Walk 2 X Slope (%)	N/A	
N/A	Ramp inside XWalk1?	N/A	N/A	Ramp inside XWalk2?	N/A	
	Road Slope (%)	N/A	N/A	Clear Space?	N/A	
	Road X Slope (%)	N/A	N/A	Clear Space to XWalk (in)	N/A	
N/A	Any Obstructions?	N/A	N/A	Storm Grate/Utility Hazard?	N/A	
	Obstruction Type			Storm Grate/Utility Type		
		N/A			N/A	
			Yes	Surface Condition? (G/P)	Good

Possible Solutions:	<u>c</u>
Remove & Replace Entire Ramp.	N
	Υ
	N
	N
	N
	N
Surveyor Notes:	N
N/A	N
	N
	N
	N
PROW/ADA:	N
Not Found, R304.5.3	N
	N
	N

Total Cost: \$ 1850.00
