# Access Compliance Report

## Public Rights-of-Way

### (Curb Ramps)

Intersection ID: 48945	Main Street: DAVID_JENNINGS_AV	Cross Street: CALDWELL_RIDGE_PY	Location:	N
ADA ID: 8A21C2B87215	Ramp Type: Combination2	Initial Pass/Fail: Fail	Overall Compliance: No	Severity Score: 10

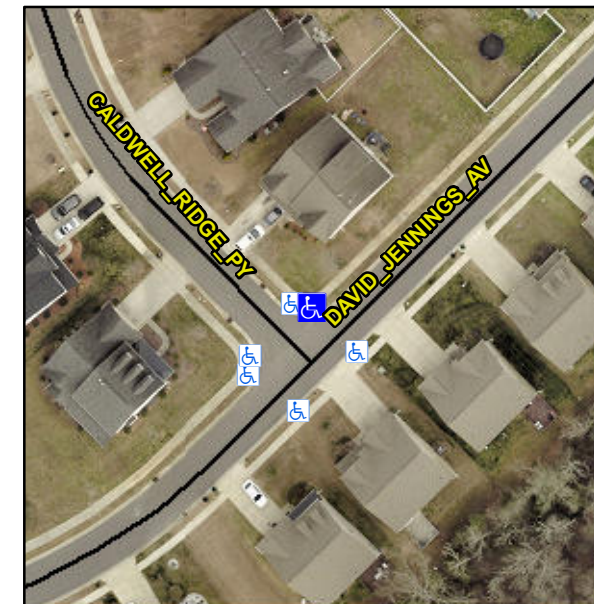
**RT RP < 5%**

**Not Found, R304.5.1, R304.5.3**

Compliance	Description	Data	Compliance	Description	Data
N/A	Ramp Length LT (in)	13.0	N/A	Ramp Length RT (in)	16.5
Yes	Ramp Width LT (in)	59.0	N/A	Ramp Width RT (in)	59.0
Yes	Ramp Slope LT (%)	6.1	N/A	Ramp Slope RT (%)	4.9
No	Ramp XSlope LT (%)	2.3	N/A	Ramp XSlope RT (%)	2.6
N/A	Ramp Length (in)	47.0	Yes	Ramp Slope (%)	6.8
No	Ramp Width (in)	39.0	No	Ramp XSlope (%)	2.9
N/A	Flare Type LT	N/A	N/A	Flare Type RT	N/A
N/A	Flare Slope LT (%)	N/A	N/A	Flare Slope RT (%)	N/A
N/A	Flare Traversable LT?	N/A	N/A	Flare Traversable RT?	N/A
N/A	Landing Length (in)	N/A	N/A	DWS Provided?	N/A
N/A	Landing Width (in)	N/A	N/A	DWS Contrast?	N/A
N/A	Landing Slope (%)	N/A	N/A	DWS Length (in)	N/A
N/A	Landing X Slope (%)	N/A	N/A	DWS Full Width?	N/A
N/A	Landing Curb? (Y/N)	N/A	N/A	DWS Offset (in)	N/A
N/A	Shared Landing?	N/A			
N/A	Gutter Ponding?	N/A	N/A	Gutter Slope (%)	N/A
N/A	Gutter Lip Ht (in)	N/A	N/A	Gutter X Slope (%)	N/A
N/A	Painted X Walk1?	No	N/A	Painted X Walk2?	N/A

**Remove & Replace Entire Ramp.**
