Access Compliance Report Public Rights-of-Way (Curb Ramps)

Intersection ID: 25287 Main Street: CEDAR_POINT_LN Cross Street: JOHNSTON_RD Location: NE
ADA ID: 8A667889C4AD Ramp Type: PerpDiag Initial Pass/Fail: Fail Overall Compliance: No Severity Score: 25

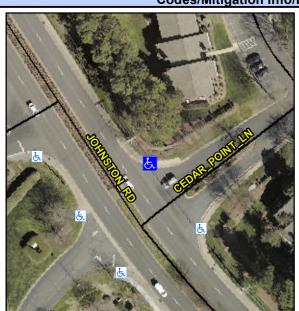
Not Found, R304.2.2, R304.5.3

rieiu ivieasure	ements/C	ompo	nent Comphance	
Comp	liance Description	Data	Compliance Description		Data
N/A	Ramp Length (in)	60.0	No	Ramp Slope (%)	9.2
Yes	Ramp Width (in)	48.0	No	Ramp XSlope (%)	5.5
N/A	Flare Type LT	N/A	N/A	Flare Type RT	N/A
N/A	Flare Slope LT (%)	N/A	N/A	Flare Slope RT (%)	N/A
N/A	Flare Traversable LT?	N/A	N/A	Flare Traversable RT?	N/A
N/A	Landing Length (in)	N/A	N/A	DWS Provided?	N/A
N/A	Landing Width (in)	N/A	N/A	DWS Contrast?	N/A
N/A	Landing Slope (%)	N/A	N/A	DWS Length (in)	N/A
N/A	Landing X Slope (%)	N/A	N/A	DWS Full Width?	N/A
N/A	Landing Curb? (Y/N)	N/A	N/A	DWS Offset (in)	N/A
N/A	Shared Landing?	N/A			
N/A	Gutter Ponding?	N/A	N/A	Gutter Slope (%)	N/A
N/A	Gutter Lip Ht (in)	N/A	N/A	Gutter X Slope (%)	N/A
N/A	Painted X Walk1?	No	N/A	Painted X Walk2?	No
	X Walk 1 Direction	To SW		X Walk 2 Direction	To SE
N/A	X Walk 1 Width (in)	N/A	N/A	X Walk 2 Width (in)	N/A
	X Walk 1 Slope (%)	4.1		X Walk 2 Slope (%)	1.9

X Walk 1 X Slope (%)	3.5		X Walk 2 X Slope (%)	4.5
N/A	Ramp inside XWalk1?	N/A	N/A	Ramp inside XWalk2?	N/A
	Road Slope (%)	4.6	N/A	Clear Space?	N/A
	Road X Slope (%)	1.2	N/A	Clear Space to XWalk (in)	N/A
N/A	Any Obstructions?	N/A	N/A	Storm Grate/Utility Hazard?	N/A
	Obstruction Type			Storm Grate/Utility Type	
		N/A			N/A
			Yes	Surface Condition? (G/P)	Good

Remove & Replace Curb Ramp With Two New Directional Ramps or Equivalent.
