Access Compliance Report

Public Rights-of-Way

(Curb Ramps)

Intersection ID: 49397	Main Street: HERFORD_ST	Cross Street: DAMASCUS_ST	Location: SE
ADA ID: 8AE8D2DA8D51	Ramp Type: PerpDiag	Initial Pass/Fail: Fail	Overall Compliance: No
		Severity Score: 21.25

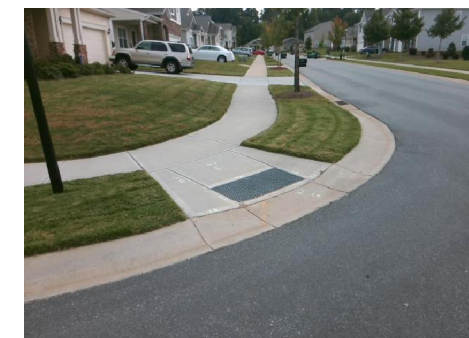
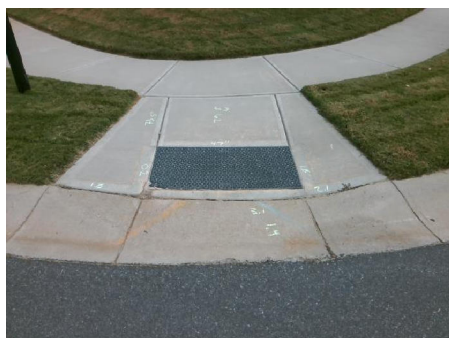
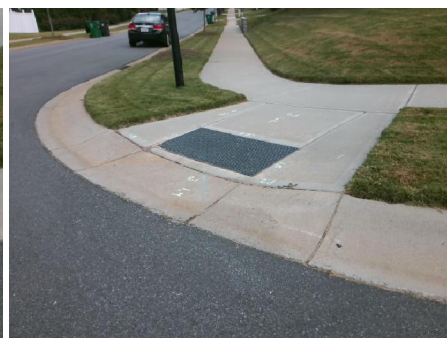
Not Found, R304.5.1, R304.5.3

Compliance	Description	Data	Compliance	Description	Data
N/A	Ramp Length (in)	73.5	Yes	Ramp Slope (%)	6.2
No	Ramp Width (in)	47.0	No	Ramp XSlope (%)	6.3
N/A	Flare Type LT	N/A	N/A	Flare Type RT	N/A
N/A	Flare Slope LT (%)	N/A	N/A	Flare Slope RT (%)	N/A
N/A	Flare Traversable LT?	N/A	N/A	Flare Traversable RT?	N/A
N/A	Landing Length (in)	N/A	N/A	DWS Provided?	N/A
N/A	Landing Width (in)	N/A	N/A	DWS Contrast?	N/A
N/A	Landing Slope (%)	N/A	N/A	DWS Length (in)	N/A
N/A	Landing X Slope (%)	N/A	N/A	DWS Full Width?	N/A
N/A	Landing Curb? (Y/N)	N/A	N/A	DWS Offset (in)	N/A
N/A	Shared Landing?	N/A			
N/A	Gutter Ponding?	N/A	N/A	Gutter Slope (%)	N/A
N/A	Gutter Lip Ht (in)	N/A	N/A	Gutter X Slope (%)	N/A
N/A	Painted X Walk1?	No	N/A	Painted X Walk2?	No
	X Walk 1 Direction	To N		X Walk 2 Direction	To W
N/A	X Walk 1 Width (in)	N/A	N/A	X Walk 2 Width (in)	N/A
	X Walk 1 Slope (%)	1.8		X Walk 2 Slope (%)	1.8
	X Walk 1 X Slope (%)	0.2		X Walk 2 X Slope (%)	2.1

N/A	Ramp inside XWalk1?	N/A	N/A	Ramp inside XWalk2?	N/A
	Road Slope (%)	3.1	N/A	Clear Space?	N/A
	Road X Slope (%)	1.4	N/A	Clear Space to XWalk (in)	N/A
N/A	Any Obstructions?	N/A	N/A	Storm Grate/Utility Hazard?	N/A
	Obstruction Type			Storm Grate/Utility Type	
		N/A			N/A
			Yes	Surface Condition? (G/P)	Good

Remove & Replace Curb Ramp With Two New Directional Ramps or Equivalent.
