# Access Compliance Report

## Public Rights-of-Way

### (Curb Ramps)

Intersection ID: 50606	Main Street: DENBUR_DR	Cross Street: BENDING_BRANCH_RD	Location: S
ADA ID: 8B0DBEDE08DB	Ramp Type: Perp	Initial Pass/Fail: Fail	Overall Compliance: No
Severity Score: 13.75			
Codes/Mitigation Info/Possible Solution		Field Measurements/Component Compliance

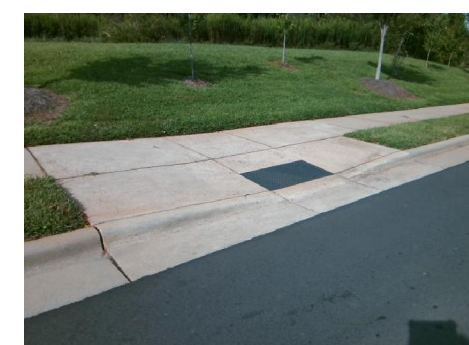
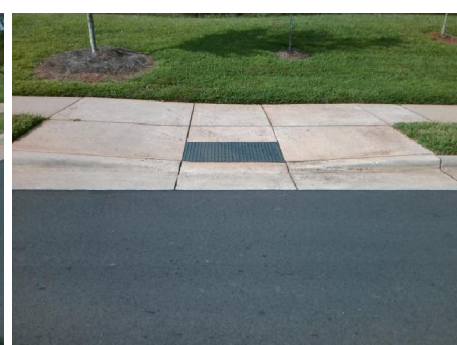
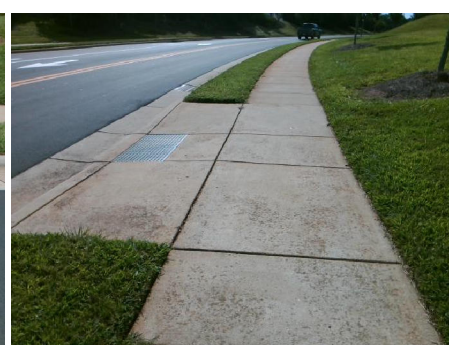
**Not Found, R304.2.2**

Compliance	Description	Data	Compliance	Description	Data
N/A	Ramp Length (in)	49.5	No	Ramp Slope (%)	11.5
Yes	Ramp Width (in)	48.0	Yes	Ramp XSlope (%)	3.7
N/A	Flare Type LT	N/A	N/A	Flare Type RT	N/A
N/A	Flare Slope LT (%)	N/A	N/A	Flare Slope RT (%)	N/A
N/A	Flare Traversable LT?	N/A	N/A	Flare Traversable RT?	N/A
N/A	Landing Length (in)	N/A	N/A	DWS Provided?	N/A
N/A	Landing Width (in)	N/A	N/A	DWS Contrast?	N/A
N/A	Landing Slope (%)	N/A	N/A	DWS Length (in)	N/A
N/A	Landing X Slope (%)	N/A	N/A	DWS Full Width?	N/A
N/A	Landing Curb? (Y/N)	N/A	N/A	DWS Offset (in)	N/A
N/A	Shared Landing?	N/A			
N/A	Gutter Ponding?	N/A	N/A	Gutter Slope (%)	N/A
N/A	Gutter Lip Ht (in)	N/A	N/A	Gutter X Slope (%)	N/A
N/A	Painted X Walk1?	No	N/A	Painted X Walk2?	N/A
	X Walk 1 Direction	To NE		X Walk 2 Direction	N/A
N/A	X Walk 1 Width (in)	N/A	N/A	X Walk 2 Width (in)	N/A
	X Walk 1 Slope (%)	2.2		X Walk 2 Slope (%)	N/A
	X Walk 1 X Slope (%)	4.4		X Walk 2 X Slope (%)	N/A

**Remove & Replace Entire Ramp.**
