# Access Compliance Report

## Public Rights-of-Way

### (Curb Ramps)

Intersection ID: 7528	Main Street: LEMSFORD_WY	Cross Street: SILCHESTER_LN	Location: S
ADA ID: 8B35124FAB75	Ramp Type: BlendTrans2	Initial Pass/Fail: Fail	Overall Compliance: No
Codes/Mitigation Info/Possible Solution		Field Measurements/Component Compliance	
Severity Score: 10

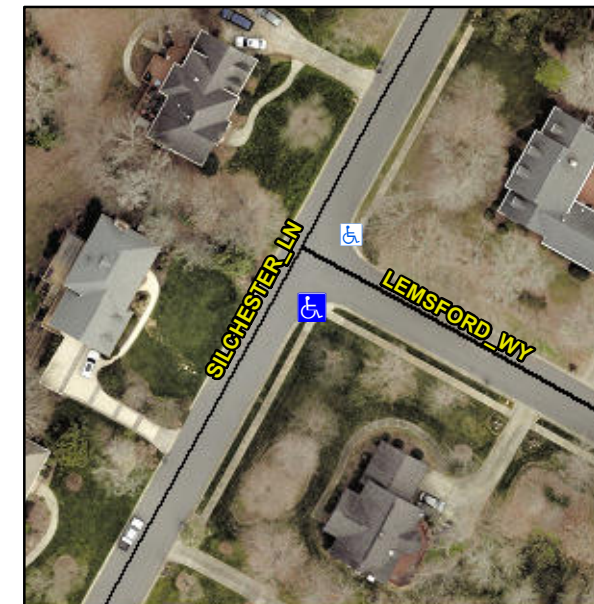
**Not Found, R304.5.1, R304.5.3**

Compliance	Description	Data	Compliance	Description	Data
N/A	Ramp Length (in)	63.5	Yes	BlendTrans Slope (%)	3.8
No	Ramp Width (in)	46.5	No	BlendTrans XSlope (%)	3.6
N/A	Flare Type LT	N/A	N/A	Flare Type RT	N/A
N/A	Flare Slope LT (%)	N/A	N/A	Flare Slope RT (%)	N/A
N/A	Flare Traversable LT?	N/A	N/A	Flare Traversable RT?	N/A
N/A	Landing Length (in)	N/A	N/A	DWS Provided?	N/A
N/A	Landing Width (in)	N/A	N/A	DWS Contrast?	N/A
N/A	Landing Slope (%)	N/A	N/A	DWS Length (in)	N/A
N/A	Landing X Slope (%)	N/A	N/A	DWS Full Width?	N/A
N/A	Landing Curb? (Y/N)	N/A	N/A	DWS Offset (in)	N/A
N/A	Shared Landing?	N/A			
N/A	Gutter Ponding?	N/A	N/A	Gutter Slope (%)	N/A
N/A	Gutter Lip Ht (in)	N/A	N/A	Gutter X Slope (%)	N/A
N/A	Painted X Walk1?	No	N/A	Painted X Walk2?	N/A
	X Walk 1 Direction	To NE		X Walk 2 Direction	N/A
	X Walk 1 Width (in)	N/A		X Walk 2 Width (in)	N/A
	X Walk 1 Slope (%)	2.1		X Walk 2 Slope (%)	N/A
	X Walk 1 X Slope (%)	3.7		X Walk 2 X Slope (%)	N/A

N/A	Ramp inside XWalk1?	N/A	N/A	Ramp inside XWalk2?	N/A
	Road Slope (%)	3.7		Clear Space?	N/A
	Road X Slope (%)	2.1	N/A	Clear Space to XWalk (in)	N/A
N/A	Any Obstructions?	N/A	N/A	Storm Grate/Utility Hazard?	N/A
	Obstruction Type			Storm Grate/Utility Type	
		N/A			N/A
			Yes	Surface Condition? (G/P)	Good
			No	Curb Slope (%)	15.4

**Remove & Replace Curb Ramp With Two New Directional Ramps or Equivalent.**
