## **Access Compliance Report Public Rights-of-Way** (Curb Ramps)

Intersection ID: 48470 Main Street: HALTON\_PARK\_DR **Cross Street: UNIVERSITY\_CITY\_BV** Location: NW ADA ID: 8B5B4B0BA360 Ramp Type: Perp Initial Pass/Fail: Fail **Overall Compliance: No** Severity Score: 33.75

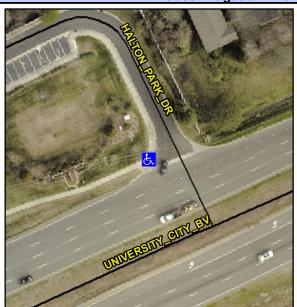
Field Measurements/Component Compliance						
Compliance Description		Data	Comp	liance Description	Data	
N	I/A	Ramp Length (in)	61.0	No	Ramp Slope (%)	16.0
N	lo	Ramp Width (in)	47.0	Yes	Ramp XSlope (%)	0.3
N	/ <b>A</b>	Flare Type LT	N/A	N/A	Flare Type RT	N/A
N	I/A	Flare Slope LT (%)	N/A	N/A	Flare Slope RT (%)	N/A
N	I/A	Flare Traversable LT?	N/A	N/A	Flare Traversable RT?	N/A
N	I/A	Landing Length (in)	N/A	N/A	DWS Provided?	N/A
N	I/A	Landing Width (in)	N/A	N/A	DWS Contrast?	N/A
N	I/A	Landing Slope (%)	N/A	N/A	DWS Length (in)	N/A
N	I/A	Landing X Slope (%)	N/A	N/A	DWS Full Width?	N/A
N	l/A	Landing Curb? (Y/N)	N/A	N/A	DWS Offset (in)	N/A
N	l/A	Shared Landing?	N/A			
N	l/A	Gutter Ponding?	N/A	N/A	Gutter Slope (%)	N/A
N	/ <b>A</b>	Gutter Lip Ht (in)	N/A	N/A	Gutter X Slope (%)	N/A
N	l/A	Painted X Walk1?	No	N/A	Painted X Walk2?	N/A
		X Walk 1 Direction	То Е		X Walk 2 Direction	N/A
N	l/A	X Walk 1 Width (in)	N/A	N/A	X Walk 2 Width (in)	N/A

Possible Solutions: Remove & Replace Entire Ramp. Surveyor Notes: N/A PROW/ADA: R304.5.1, R304.2.2
