Access Compliance Report Public Rights-of-Way (Curb Ramps)

Intersection ID: 18920 Main Street: TYVOLA_RD Cross Street: WESTPARK_DR Location: NE **Severity Score: Overall Compliance: No** ADA ID: 8B9F2B156BF6 Ramp Type: Perp Initial Pass/Fail: Fail 12.5

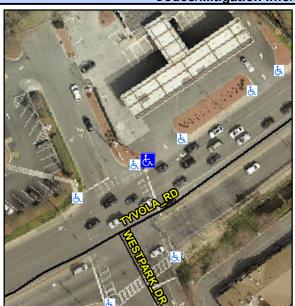
· cccibic cciation	
Possible Solutions:	Col
Remove & Replace Entire Ramp.	N/A
	Yes
	N/A
	N/A
	N/A
	N/A
Surveyor Notes:	N/A
N/A	N/A
	N/A
	N/A
	N/A
PROW/ADA:	N/A
Not Found, R304.2.2	N/A
,	N/A
	N/A
	N/A

Field Measurements/Component Compliance							
Compl	liance Description	Data	Comp	liance Description	Data		
N/A	Ramp Length (in)	48.0	No	Ramp Slope (%)	8.8		
Yes	Ramp Width (in)	48.0	Yes	Ramp XSlope (%)	1.2		
N/A	Flare Type LT	N/A	N/A	Flare Type RT	N/A		
N/A	Flare Slope LT (%)	N/A	N/A	Flare Slope RT (%)	N/A		
N/A	Flare Traversable LT?	N/A	N/A	Flare Traversable RT?	N/A		
N/A	Landing Length (in)	N/A	N/A	DWS Provided?	N/A		
N/A	Landing Width (in)	N/A	N/A	DWS Contrast?	N/A		
N/A	Landing Slope (%)	N/A	N/A	DWS Length (in)	N/A		
N/A	Landing X Slope (%)	N/A	N/A	DWS Full Width?	N/A		
N/A	Landing Curb? (Y/N)	N/A	N/A	DWS Offset (in)	N/A		
N/A	Shared Landing?	N/A					
N/A	Gutter Ponding?	N/A	N/A	Gutter Slope (%)	N/A		
N/A	Gutter Lip Ht (in)	N/A	N/A	Gutter X Slope (%)	N/A		
N/A	Painted X Walk1?	No	N/A	Painted X Walk2?	N/A		
	X Walk 1 Direction	To NW		X Walk 2 Direction	N/A		
N/A	X Walk 1 Width (in)	N/A	N/A	X Walk 2 Width (in)	N/A
