Access Compliance Report

Public Rights-of-Way

(Curb Ramps)

Intersection ID: 9251	Main Street: MORETZ_AV	Cross Street: OLANDO_ST	Location: S
ADA ID: 8BB4BFFFC9E3	Ramp Type: Para	Initial Pass/Fail: Fail	Overall Compliance: No
Severity Score: 37.5			
Codes/Mitigation Info/Possible Solution		Field Measurements/Component Compliance

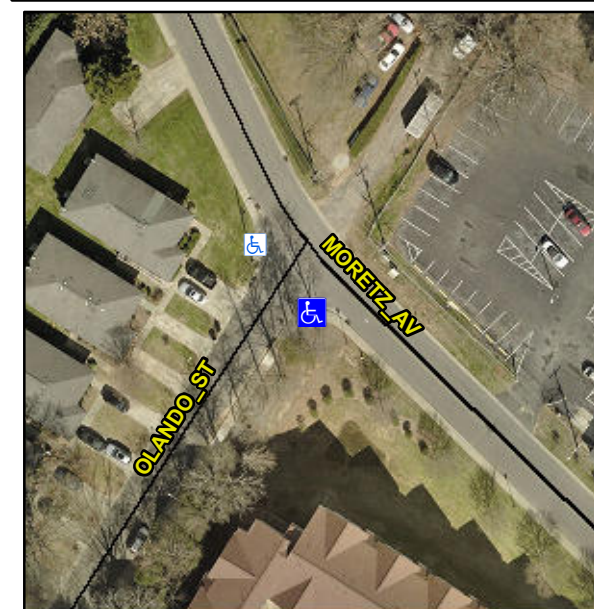
DWS NAILS EXPOSED, RT RP < 5%

R304.3.2, R304.5.3

Compliance	Description	Data	Compliance	Description	Data
N/A	Ramp Length LT (in)	49.0	N/A	Ramp Length RT (in)	53.0
Yes	Ramp Width LT (in)	59.5	Yes	Ramp Width RT (in)	62.0
No	Ramp Slope LT (%)	16.0	Yes	Ramp Slope RT (%)	2.6
No	Ramp XSlope LT (%)	5.2	No	Ramp XSlope RT (%)	2.6
N/A	Landing Length (in)	N/A	N/A	DWS Provided?	N/A
N/A	Landing Width (in)	N/A	N/A	DWS Contrast?	N/A
N/A	Landing Slope (%)	N/A	N/A	DWS Length (in)	N/A
N/A	Landing X Slope (%)	N/A	N/A	DWS Full Width?	N/A
N/A	Landing Curb? (Y/N)	N/A	N/A	DWS Offset (in)	N/A
N/A	Shared Landing?	N/A			
N/A	Gutter Ponding?	N/A	N/A	Gutter Slope (%)	N/A
N/A	Gutter Lip Ht (in)	N/A	N/A	Gutter X Slope (%)	N/A
N/A	Painted X Walk1?	No	N/A	Painted X Walk2?	N/A
	X Walk 1 Direction	To NW		X Walk 2 Direction	N/A
N/A	X Walk 1 Width (in)	N/A	N/A	X Walk 2 Width (in)	N/A
	X Walk 1 Slope (%)	3.2		X Walk 2 Slope (%)	N/A
	X Walk 1 X Slope (%)	2.7		X Walk 2 X Slope (%)	N/A
N/A	Ramp inside XWalk1?	N/A	N/A	Ramp inside XWalk2?	N/A

Remove & Replace Entire Ramp.
