# Access Compliance Report

## Public Rights-of-Way

### (Curb Ramps)

Intersection ID: 7316	Main Street: SILCHESTER_LN	Cross Street: SWINDON_CT	Location:	N
ADA ID: 8C0ED5ADC9C5	Ramp Type: Para	Initial Pass/Fail: Fail	Overall Compliance: No	Severity Score: 17.5

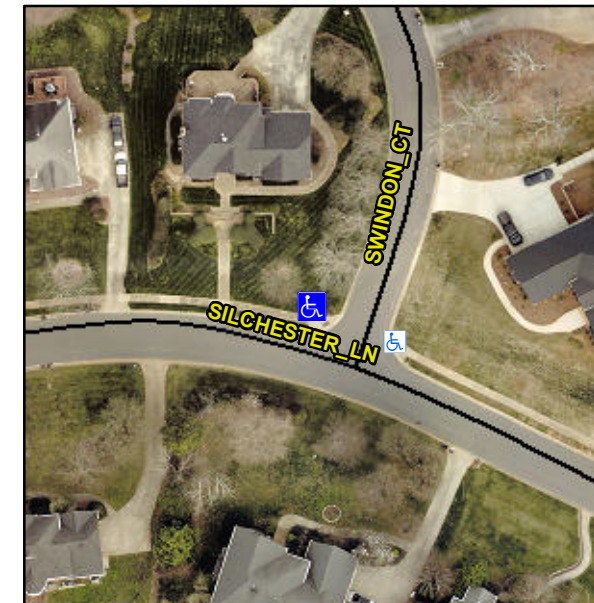
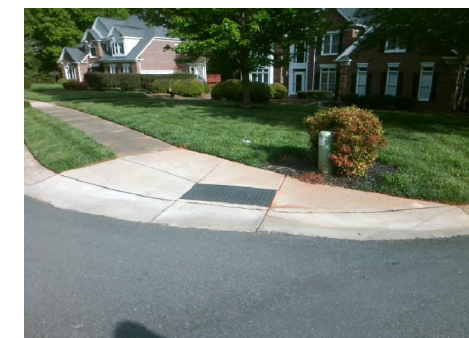
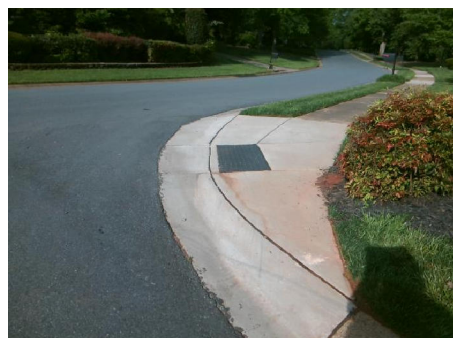
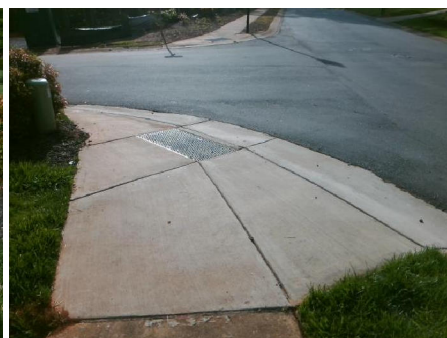
**LT RP < 5%, RT RP < 5%**

Compliance	Description	Data	Compliance	Description	Data
N/A	Ramp Length LT (in)	56.0	N/A	Ramp Length RT (in)	56.0
No	Ramp Width LT (in)	47.0	No	Ramp Width RT (in)	34.0
Yes	Ramp Slope LT (%)	3.4	Yes	Ramp Slope RT (%)	2.3
Yes	Ramp XSlope LT (%)	0.9	Yes	Ramp XSlope RT (%)	1.3
N/A	Landing Length (in)	N/A	N/A	DWS Provided?	N/A
N/A	Landing Width (in)	N/A	N/A	DWS Contrast?	N/A
N/A	Landing Slope (%)	N/A	N/A	DWS Length (in)	N/A
N/A	Landing X Slope (%)	N/A	N/A	DWS Full Width?	N/A
N/A	Landing Curb? (Y/N)	N/A	N/A	DWS Offset (in)	N/A
N/A	Shared Landing?	N/A			
N/A	Gutter Ponding?	N/A	N/A	Gutter Slope (%)	N/A
N/A	Gutter Lip Ht (in)	N/A	N/A	Gutter X Slope (%)	N/A
N/A	Painted X Walk1?	No	N/A	Painted X Walk2?	N/A
	X Walk 1 Direction	To SE		X Walk 2 Direction	N/A
N/A	X Walk 1 Width (in)	N/A	N/A	X Walk 2 Width (in)	N/A
	X Walk 1 Slope (%)	2.7		X Walk 2 Slope (%)	N/A
	X Walk 1 X Slope (%)	5.3		X Walk 2 X Slope (%)	N/A
N/A	Ramp inside XWalk1?	N/A	N/A	Ramp inside XWalk2?	N/A

Road Slope (%)	N/A	N/A	Clear Space?	N/A
	Road X Slope (%)	N/A	N/A	Clear Space to XWalk (in)	N/A
N/A	Any Obstructions?	N/A	N/A	Storm Grate/Utility Hazard?	N/A
	Obstruction Type			Storm Grate/Utility Type	
		N/A			N/A
			Yes	Surface Condition? (G/P)	Good
			Compliant	Curb Slope (%)	4.8

**Remove & Replace Entire Ramp.**
